## Laboratory Simulation of Rolling Contact Fatigue Cracks in Wind Turbine Bearings Using Hydrogen Infused 100Cr6 Bearing Steel

Janakiraman, Shravan; West, Ole; Klit, Peder; Jensen, Niels Steinfeldt

*Publication date:*  
2014

Janakiraman, S., West, O., Klit, P., & Jensen, N. S. (2014). *Laboratory Simulation of Rolling Contact Fatigue Cracks in Wind Turbine Bearings Using Hydrogen Infused 100Cr6 Bearing Steel*. Paper presented at 16th Nordic Symposium on Tribology, Aarhus, Denmark.

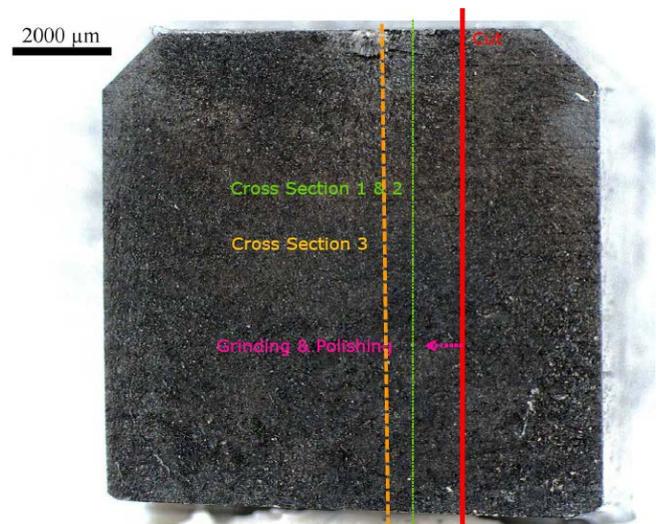
**Figure 2 :** Stereomicroscope image of the fracture surface of ring B1

A cut is made along the red line in (Fig. 2) and the sample is mounted. The specimen is then ground and polished, with material removed in the axial direction, until faces close to the crack are reached. White Etching Areas are usually observed in these axial cross sections. However, there may be some cross sections where the white areas might not be found as the total number of WEA can be small. Thus, the probability of finding a White Etching Area close to a crack

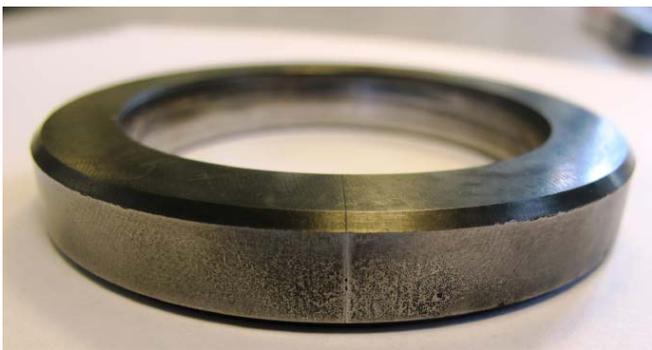
**Figure 3 :** Axial crack on ring B1.

(**Fig. 3**) and (**Fig. 4**) show the fracture surfaces of the ring B1 that fractured after 11 million cycles. A cross

material is similar to the material of the test ring specimens used for testing. These cracks look similar to the axial crack on the surface of the ring B1 (**Fig. 3**). The failed bearing inner ring from service are sectioned, polished, etched and viewed under a microscope. Their failure characteristics are then compared to the failure characteristics in the laboratory simulated RCF rings.

(**Fig. 3**) and (**Fig. 8**) also show pitting on the surface of the test specimen. Pitting could occur due to the presence of small solid contaminants in the lubricant, or due to a subsurface cracks growing to the surface.

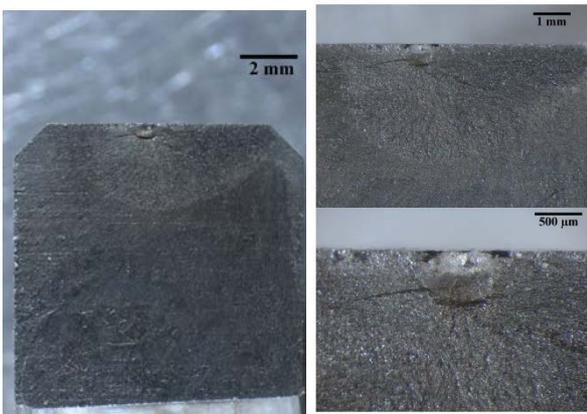
**Figure 4:** Stereomicroscope images of the fracture surface of ring B1

(**Fig. 4**) and (**Fig. 5**) shows a resemblance to the fractured sample in the ball bearing fatigue test conducted by Clark [2]. The fracture surface shows a difference in texture between the top and bottom of the specimen. The rough, rounded portion close to rolling surface appears to have fractured by fatigue while the smooth lower portion appears to have fractured in a brittle manner.

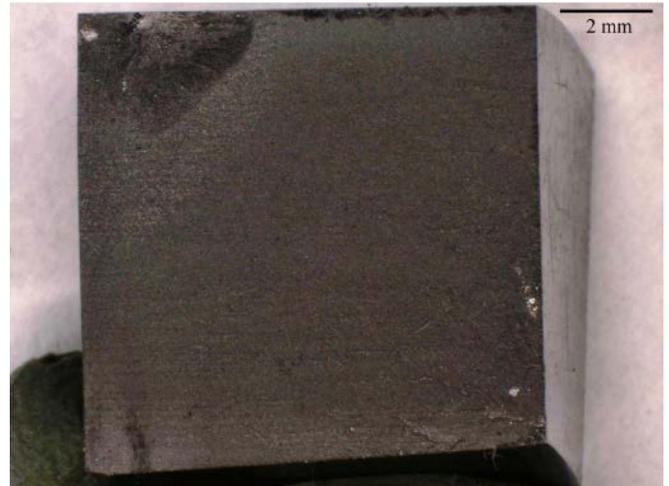
**Figure 5:** Stereomicroscope image of the fracture surface of the ring A2

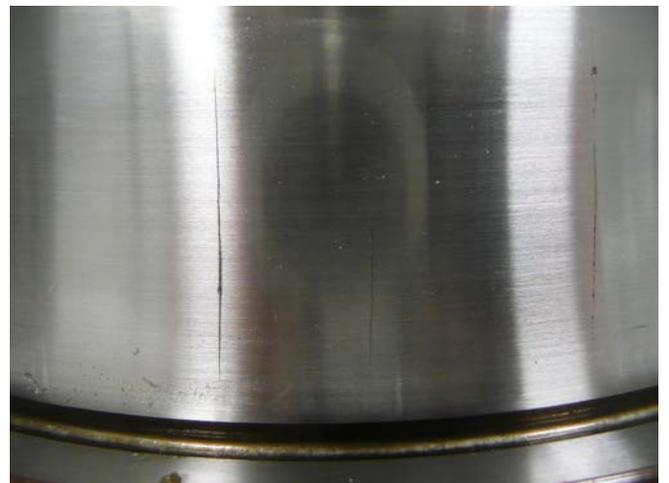
**Figure 6:** Axial crack on the inner ring of a bearing from service

(**Fig. 6**) shows multiple axial cracks on the inner ring of a tapered roller bearing from service. The bearing was positioned on the shaft at the intermediate stage inside the gearbox of a wind turbine. The gearbox belonged to a 2.3 MW turbine. The material is a through-hardened martensitic bearing steel. This

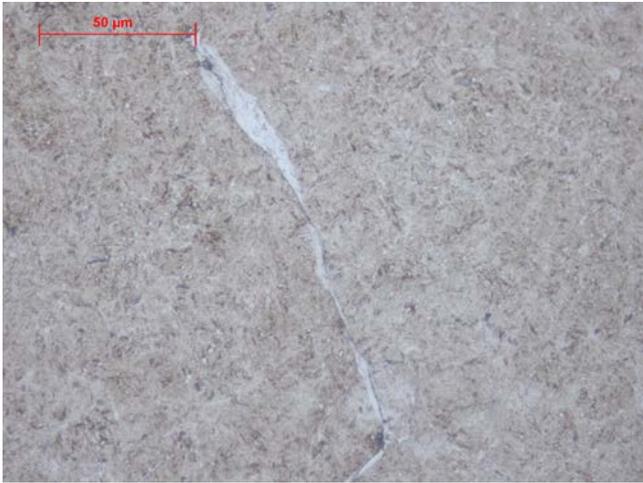
**Figure 7:** RLM image of a nital etched axial cross section (cut parallel to the over-rolling direction) showing a White Etching Area (WEA) around a crack in the inner ring of the bearing.

(**Fig. 7**) shows a characteristic WEA around a crack in an axial cross section of the bearing inner ring surface. It has been suggested by Kino et al., [6] that hydrogen plays a role in the formation of these WEA. Uyama [6] studied these WEA using a Transmission Electron Microscope (TEM) and observed that the white structure consisted of an ultra fine grained structure. He further suggested that the localized microstructural changes are caused by the hydrogen and hence supposed that the basic role of hydrogen is to localize plasticity.

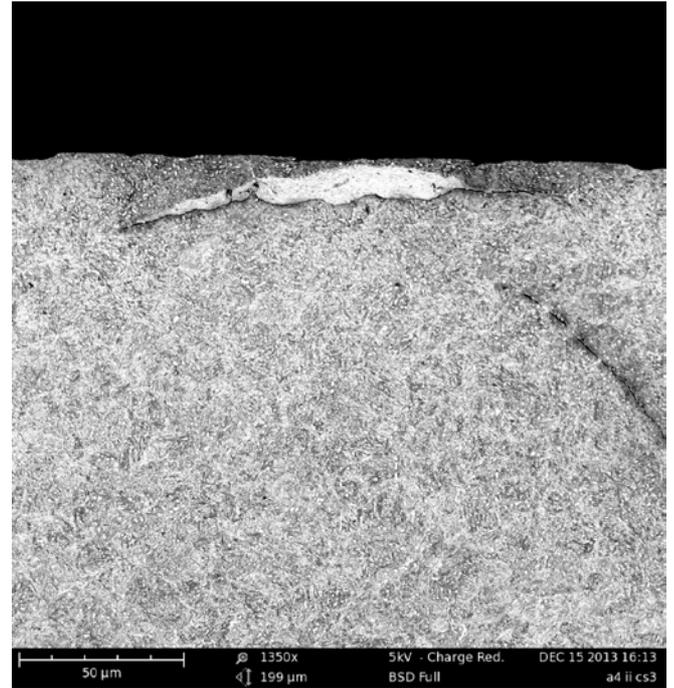
(**Fig. 8**) shows a WEA found in an axial cross section near a crack formed subsurface. This crack is less than 20 microns from the rolling surface. This is believed to be because raised levels of hydrogen closer to the rolling surface, weaken the material and make it more susceptible to crack initiation. Evans [5] showed that decreasing the levels of hydrogen artificially infused in the surface of the ring causes these cracks to be formed much further away below the rolling surface.

**Figure 8:** WEA found near a crack on the failed lab specimen B2

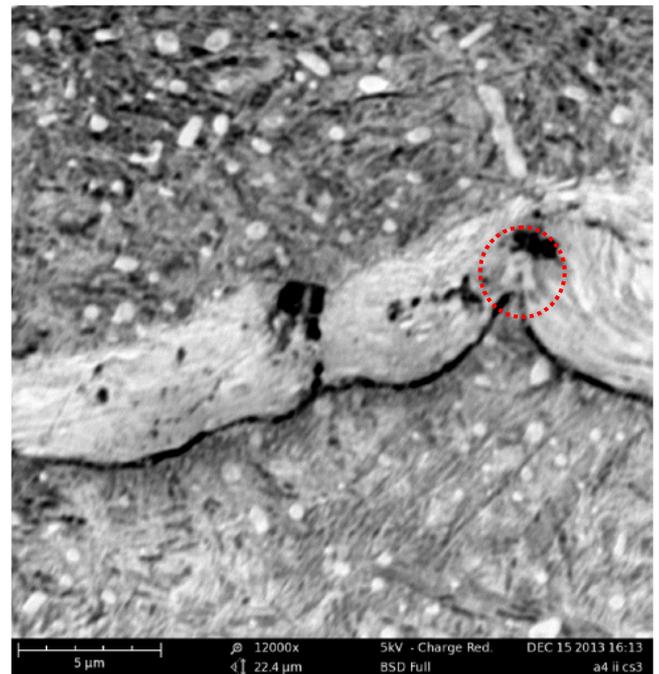
(**Fig. 8**) shows a highly magnified SEM image of the WEA. The light triangular shaped region within the red dotted circle is suspected to be a deformity like an inclusion or a void formed at the location of a former inclusion, just like Evans [5] had predicted, although

not yet confirmed by performing EDAX studies. The shape of the crack also seems to resemble the butterfly cracks described by Evans in the same paper.

**Figure 9:** SEM image of the WEA around the crack
