The impact of tool wear on the functionality of replicated polymer surface with micro structures

D. Li¹, Y. Zhang¹, F. Regi¹, G. Tosello¹, J. B. Nielsen²

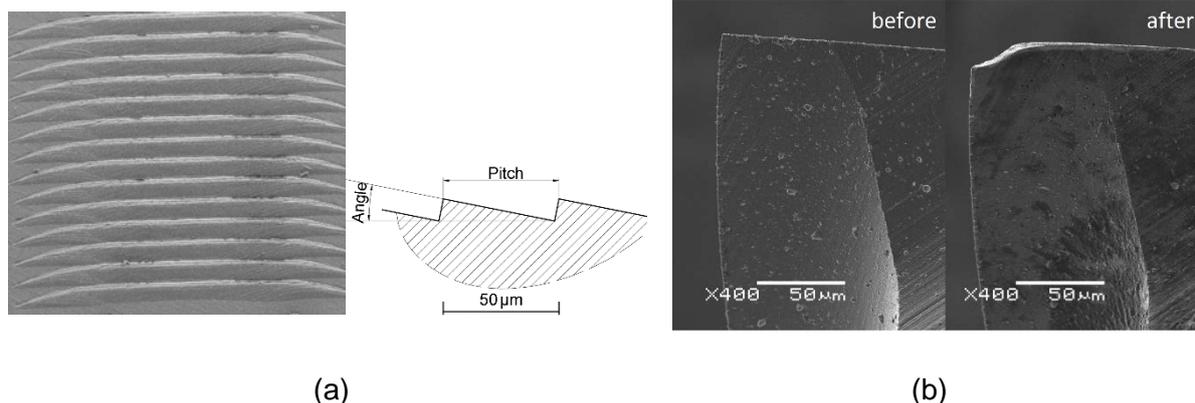
Results in this study include: 1. Tool wear was visualized by SEM images, which is shown in figure 1 (b). 2. However, the weight decrease could not be detected due to lack of precision in the measurement. 3. The number of defects on the obtained surface structures increased significantly along with the process. 4. The reflectance of these pixels on the LSR replica decreased from the first machined one to the last one.

As a conclusion, the tool (Φ 0.5mm, ARNO[®]) used in this study worn after machining for approximately 100 pixels, considering the function loss of replica surface. Future work will be dedicated to the methods that can prolong the tool life.

Figure 1: (a). Structures on the surface; (b). Wear on the tip of the tool was observed after machining
