## The impact of tool wear on the functionality of replicated polymer surface with micro structures

*Publication date:*  
2017

# The impact of tool wear on the functionality of replicated polymer surface with micro structures

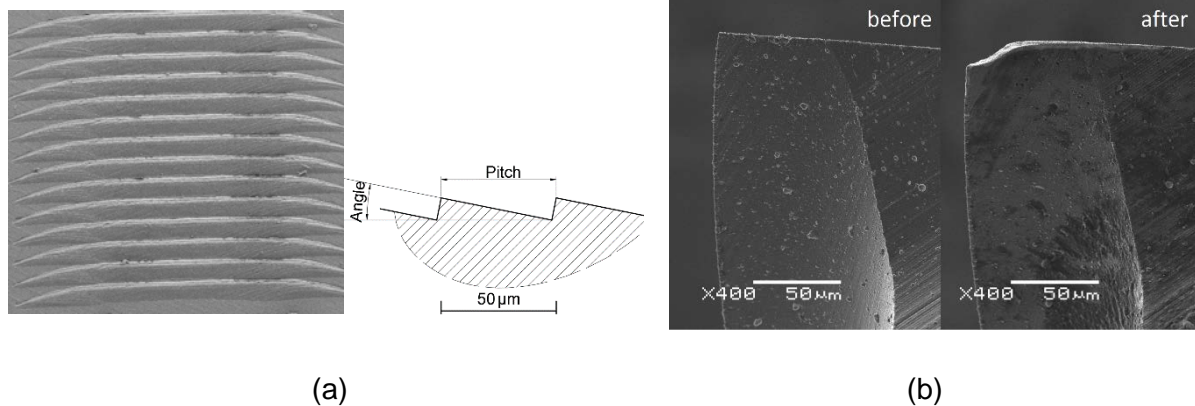
Results in this study include: 1. Tool wear was visualized by SEM images, which is shown in figure 1 (b). 2. However, the weight decrease could not be detected due to lack of precision in the measurement. 3. The number of defects on the obtained surface structures increased significantly along with the process. 4. The reflectance of these pixels on the LSR replica decreased from the first machined one to the last one.

As a conclusion, the tool ( $\Phi$  0.5mm, ARNO<sup>®</sup>) used in this study worn after machining for approximately 100 pixels, considering the function loss of replica surface. Future work will be dedicated to the methods that can prolong the tool life.

**Figure 1:** (a). Structures on the surface; (b). Wear on the tip of the tool was observed after machining
