Coastal Erosion and Flooding Hazards on the North Sea Coast at Thyboron, Denmark

Sørensen , P., Sørensen, C. S., Nielsen, P., Ciocan, R., & Knudsen, P. (2016). Coastal Erosion and Flooding Hazards on the North Sea Coast at Thyboron, Denmark. Poster session presented at International Coastal Symposium 2016, Sydney, Australia.

COASTAL EROSION AND FLOODING HAZARDS ON THE NORTH SEA COAST AT THYBORON, DENMARK

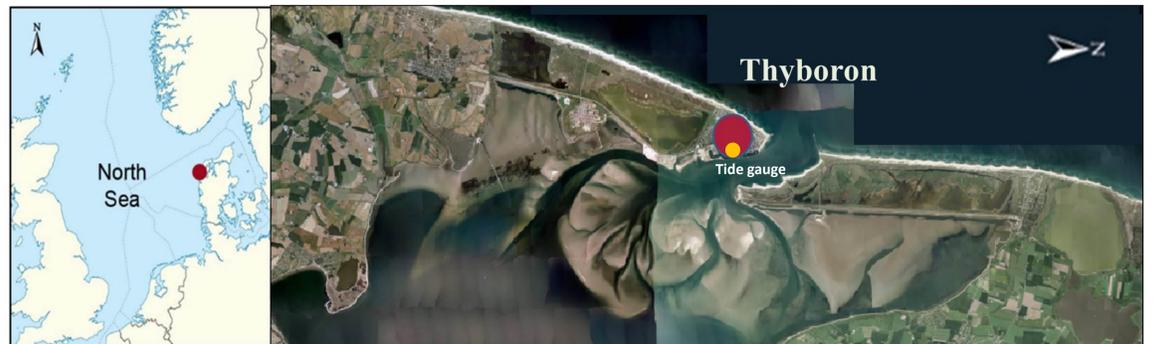
Figure 1. The Danish North Sea coast at Thyboron, the channel, and the flood tidal delta inside the Lim Fiord.

Since a breach of the coastal barrier in 1862, the Thyboron Channel connecting the North Sea and the Lim Fiord has been artificially maintained by construction of breakwaters and groins on the North Sea coast and inside the channel, respectively. Sand nourishment schemes have since the 1980s counteracted the natural erosion in the upper profile on the North Sea coast where the alongshore sediment transport converges towards the channel and deposits up to 1 million m³/y on the flood tidal delta inside the fiord, Figure 1.

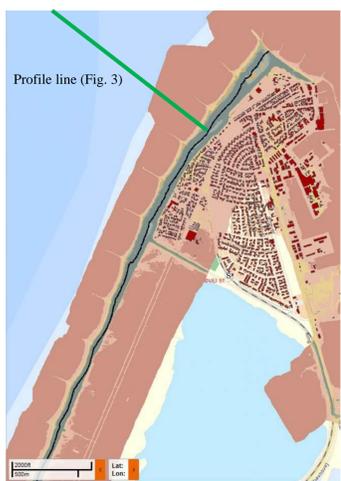
Figure 2. Small sandy barriers (green) provide safety. In black is the safety line. Flood prone areas in red and yellow.

The open coast still experiences net erosion in the lower parts of the profile, and Figure 2 shows the narrow sandy barrier which protects Thyboron from getting flooded. Each year the barriers on each side of the channel are nourished with 500,000 m³ of sand on average. This volume is sufficient to stop the retreat of the upper profile to -6 m DVR90. However, this amount has to be increased by 20 % until 2050 as the coastal steepening continues, Figure 3, to counteract the increased sand depletion of the upper profile.

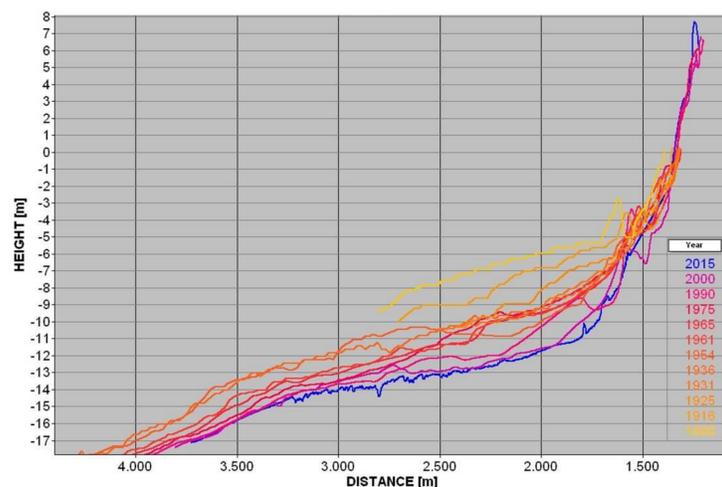
Figure 3. Coastal profile evolution, 1900-2015. The upper profile from -6 m DVR90 has been sand nourished since the late 1980's. Profile line shown in Figure 2.

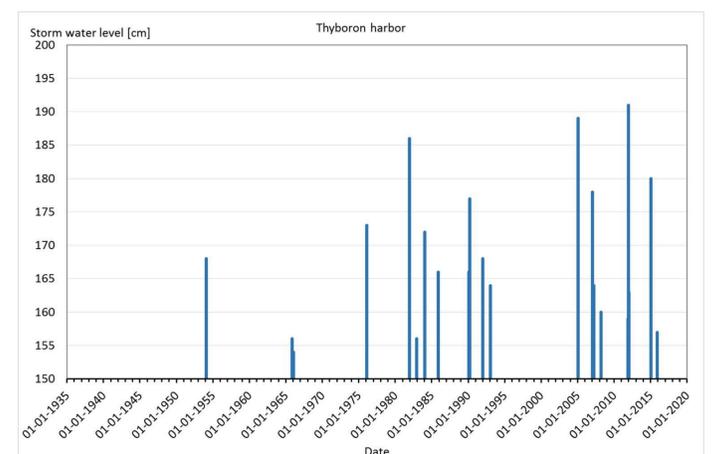
Figure 4. Heights of storm surge levels above 150 cm DVR90 at Thyboron Harbor tide gauge since 1935. Gauge position in Figure 1.

The cross-sectional area of the channel is out of equilibrium with the tidal prism and increases; leading to more extreme storm surge levels inside the fiord, Figure 4. Furthermore, the town of Thyboron experiences a differentiated net land subsidence of 2-8 mm/y. The increased cross-section, land subsidence and climate changes together will increase the future flood risk in Thyboron significantly, Figure 5.

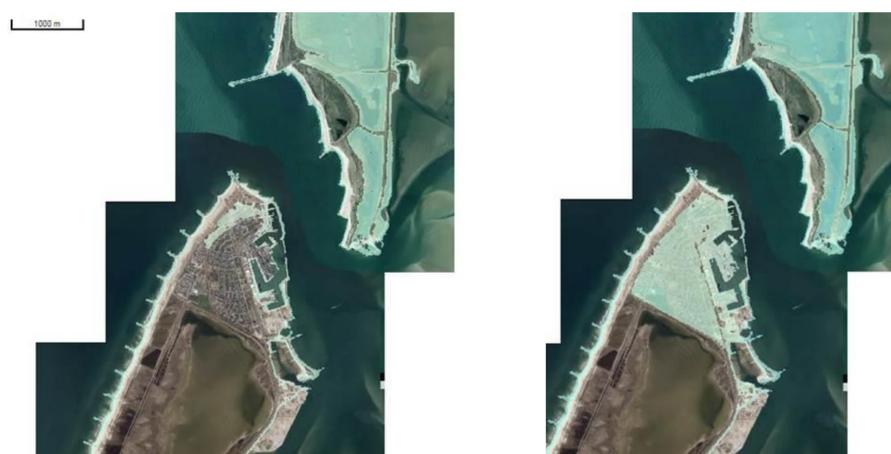
Figure 5. Potential flooding extent from a storm surge at Thyboron Harbor with a return period of 50 years in 2016 (left) and in 2060 including sea level rise and land subsidence.

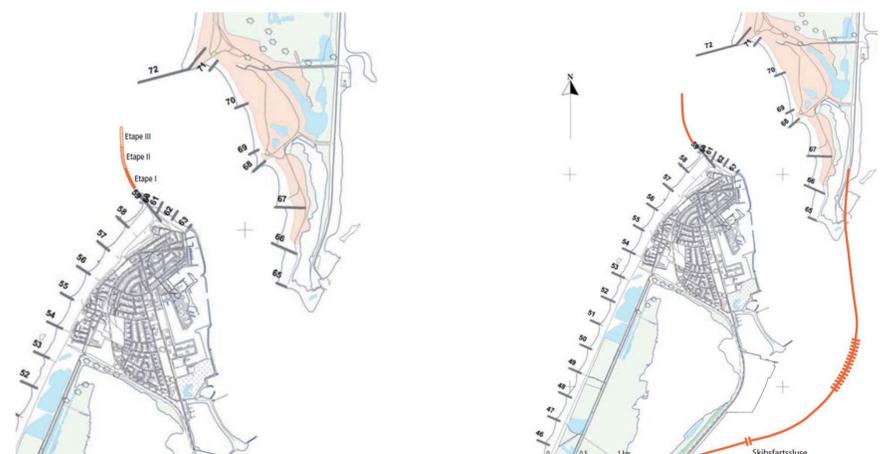
Figure 6. Technically preferred management option: extending a groin to a breakwater (left) and an alternative management option with a sluice.

Eight different options to manage the erosion and flooding hazards in the future have been analyzed. The technically preferred option is to extend of one of the groins to reduce the cross-sectional area to reduce the net erosion rates on the barriers, to limit storm surge water levels, and to makes it easier to enter the navigation channel. A sluice solution has also been analyzed due mainly to environmental issues, Figure 6. A more detailed analysis work is still necessary, however, in order to effectively deal with the combined erosion and flood hazard challenges and to decide upon the optimal solution for the future protection of Thyboron and the Lim Fiord barriers.
