# A lime based mortar for thermal insulation of medieval church vaults

P. K. Larsen<sup>1</sup>, T.K. Hansen<sup>2</sup>

**Abstract** –A new mortar for thermal insulation of medieval church vaults was tested in a full scale experiment in Annisse Church, DK. The mortar consists of perlite, a highly porous aggregate, mixed with slaked lime. These materials are compatible with the fired clay bricks and the lime mortar joints. The lambda-value of the insulation mortar is 0.08 W/m K or twice the lambda-value for mineral wool. The water vapour permeability is equal to a medieval clay brick, and it has three times higher capacity for liquid water absorption. The mortar was applied to the top side of the vaults in a thickness of 10 cm, and covered by 10 mm lime plaster, reinforced with cattle hair. This assembly can carry the weight of a person, working with maintenance of the roof. Climate measurements confirmed excellent properties in regards to both moisture transport and thermal insulation. Condensation did not occur at any time, despite a water vapour pressure gradient up to 500 Pa between the nave and attic. There was no reduction in energy consumption the first winter, possibly du

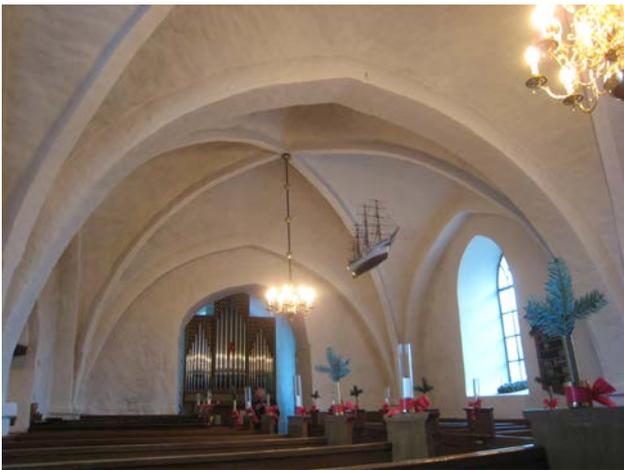
*Figure 1. Interior view of the nave and the attic in Annisse Church*

A test of vault insulation was performed in Annisse Church, located in northern Zeeland, DK. The nave and chancel date to the 12<sup>th</sup> century and have lime washed stone walls. The cross arched vaults were constructed around 1400 with fired clay bricks and lime mortar. The tiled roof and the timber construction are from 1967. The total floor area of the nave and chancel is app. 120 m<sup>2</sup> and the volume is app. 500 m<sup>3</sup>. The church has electric heating with heating elements mounted in the pews and on the walls
