Published in:
Journal of Cultural Heritage

Publication date:
2015

Electrochemical desalination of historic Portuguese tiles – removal of chlorides, nitrates and sulfates

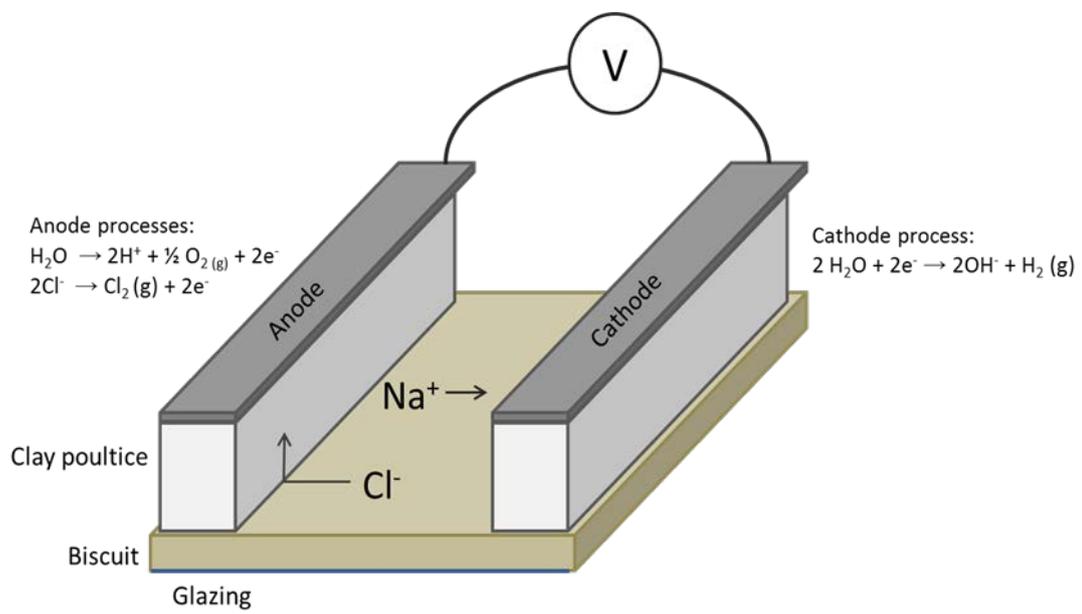
Figure 1. Laboratory setup and principle in electrochemical desalination of single tile. The electrodes are placed in clay poultice on the surface of the biscuit opposite to the glaze

During electrochemical desalination electrodes are placed externally on the surface of the salt infected material. Figure 1 shows the setup and principle for electrochemical desalination of a tile. At both electrodes there are pH changes due to electrolysis reactions:

The tile was placed with the glazing down and two plastic frames with clay poultice were placed as shown at figure 1. The clay poultice was a mixture of kaolinite and CaCO_3 [15]. Electrode meshes were placed on the top of the poultice. The electrodes were inert meaning that they serve only as a source or sink for electrons without playing a chemical role in the electrode reactions. Finally the electrodes were connected to a power supply (Hewlett Packard E3612A). Tile A was placed in a desiccator over but not in contact with water during the desalination to have a high relative humidity around the tile to hinder drying. The desiccator though had a small opening in the top in order to let the

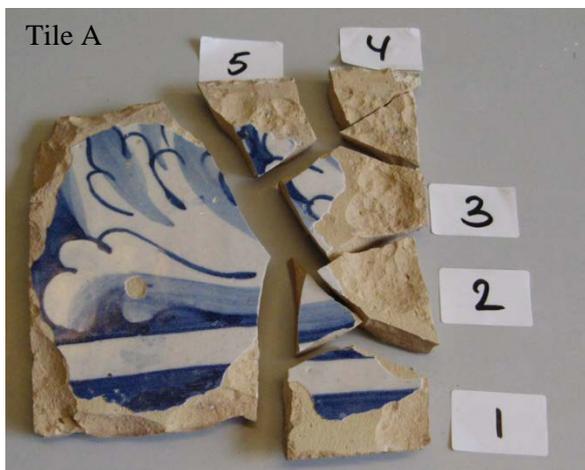
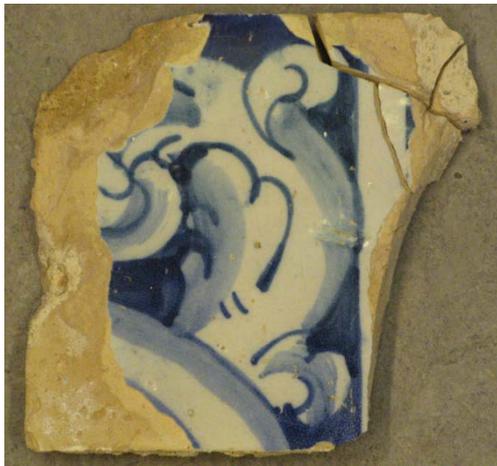
Figure 2

Figure 2: The two salt damaged tiles used in the experimental work.

Two XVIII century tiles from Palácio Centeno, Lisbon, Portugal were used (figure 2). The tiles were removed during renovation and loosened from the mortar on the back. They were part of tile panels, which suffered severely from salt decay. The panels were removed tile by tile for desalination by submersion, but due to the poor condition of some of the tiles (among others the experimental tiles) it was decided not to use them again. The original dimensions of the tiles were 14 x 14 x 1.5 cm, but the tiles had lost corners and had irregular shapes.

They suffered from severe loss of glazing. Initial samples were taken with hammer and chisel from the tiles for evaluation of the salt content: A (5 samples) and tile B (3 samples), see figure 2.

The glazing is generally lost from the outer edges of the tiles (figure 2), which is a common pattern for salt contaminated tiles [2]. The glazing of the experimental tiles is cracked and disintegrated in flakes few mm from the edge of the glaze. When removing such loosened flakes and investigating the surface opposite to the glazing in SEM, salt crystals are seen on every flake investigated (figure 3 is an example from a tile from Centeno Palace). Elemental mapping (SEM-EDX) reveals that these crystals are NaCl. Nitrogen is not found under the glaze even

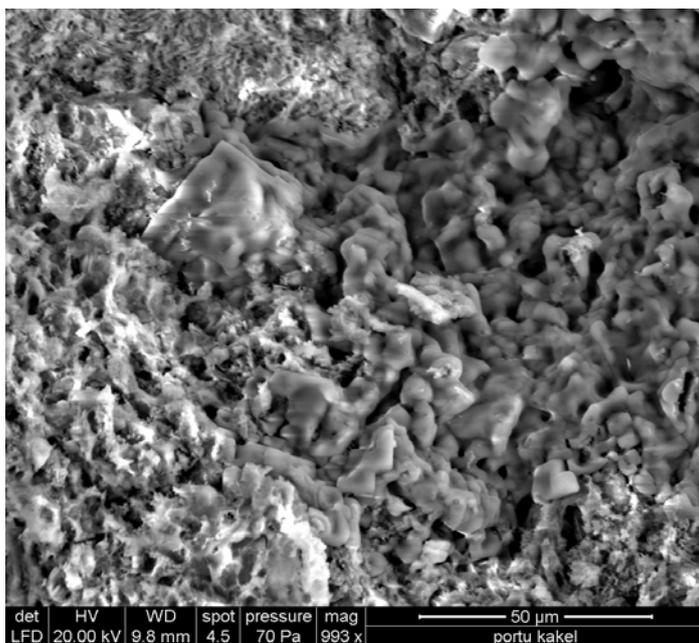
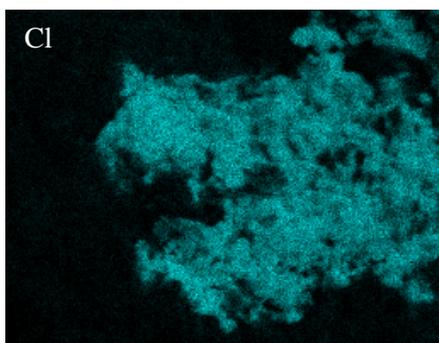
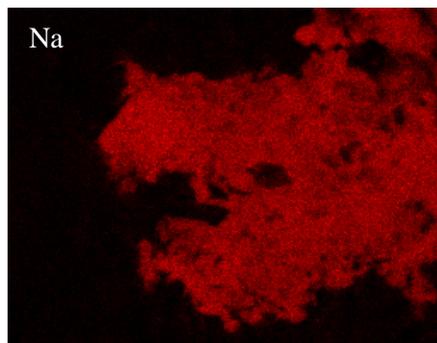
Figure 3

Figure 3: Example of SEM-EDX investigation of the back side of lifted glaze. The elemental mapping reveals that the salt crystals are NaCl

though the overall concentration of nitrate in the tiles is very high (table 2). This shows that different salts behave differently as described in e.g. [20]. The salt crystals are probably worsening the disintegration of glaze, but whether the crystallization occurred after disintegration or before cannot be concluded from this investigation.

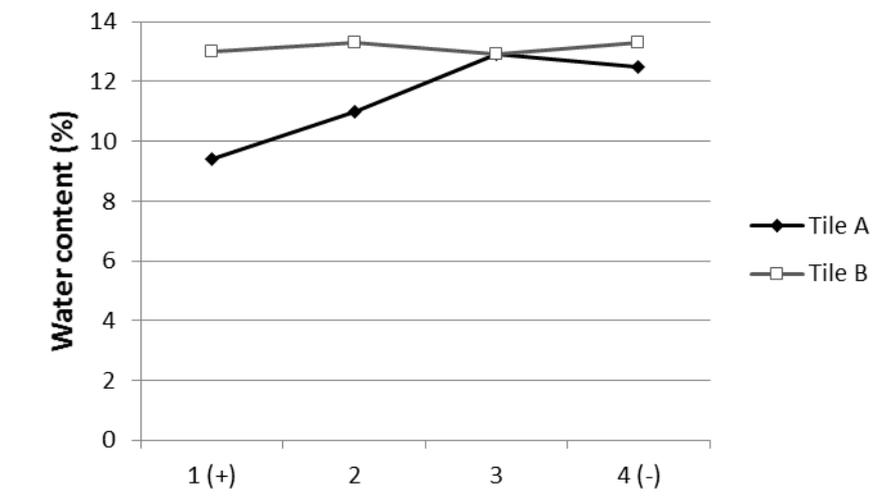
Figure 4

Figure 4: Water content in tiles at the end of desalination experiments.

The profiles of water content (figure 4) and pH (figure 5) in the tiles at the end of the experiments are shown as average values for the two rows from the segmentation. The initial pH in tile (A) and (B) are 8.2 and 8.5, respectively. The pH in the tiles increased during the desalination experiments with up to 2 pH-units. The acid produced at the anode is thus successfully neutralized by the poultice. The final water content in tile A must be almost constant at about 13% throughout the tile, while the water content varies more in tile B (between 9.5 and 13%) (figure 4). The tiles had dried out from initially 17% and 13%, respectively. The electric resistance of a tile depends both on the water content and the ionic concentration in the pore solution and the mutual influence can to some extent be determined by measuring spontaneous potentials (streaming potentials) during rising damp [21], however such measurement was not included in the present investigation.

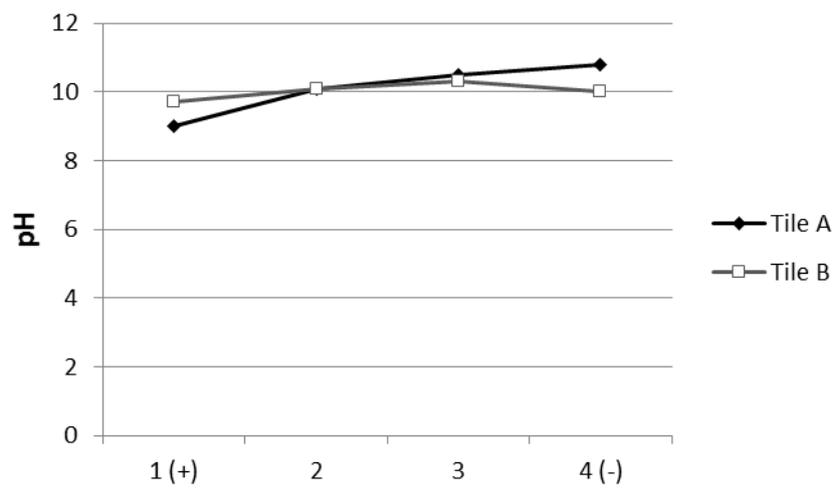
Figure 5

Figure 5: pH in tiles at the end of desalination experiments.

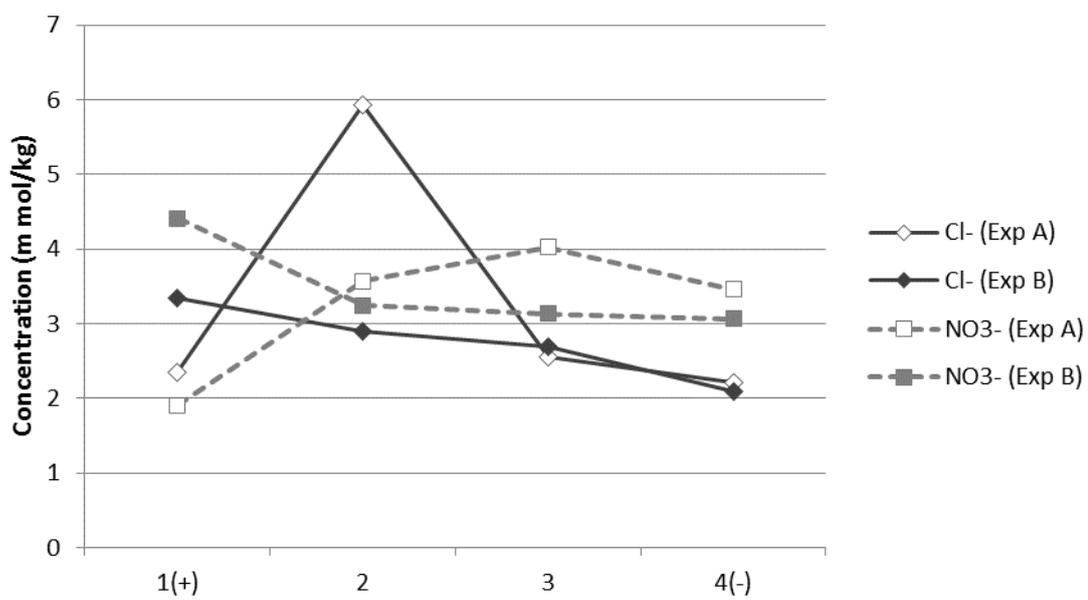
Figure 6: final concentration profiles of Cl and NO₃ in the tiles

Figure 6 shows final concentration profiles of Cl^- and NO_3^- in the tiles (average concentrations of the two profiles from the segmentation). There is a good agreement between the two profiles from each tile such as was reported in [5]. Thus possible concentration variations were leveled out during treatment. All concentrations of Cl^- and NO_3^- were well below the lower level of the ÖNORM [19], so the desalination was successful. The average molar concentrations for NO_3^- and Cl^- are similar. For chloride the concentrations were 3.3 m mole/kg and 2.8 m mole/kg for experiment A and B, respectively. For nitrate the corresponding concentrations were 3.2 m mole/kg and 3.5 m mole/kg.

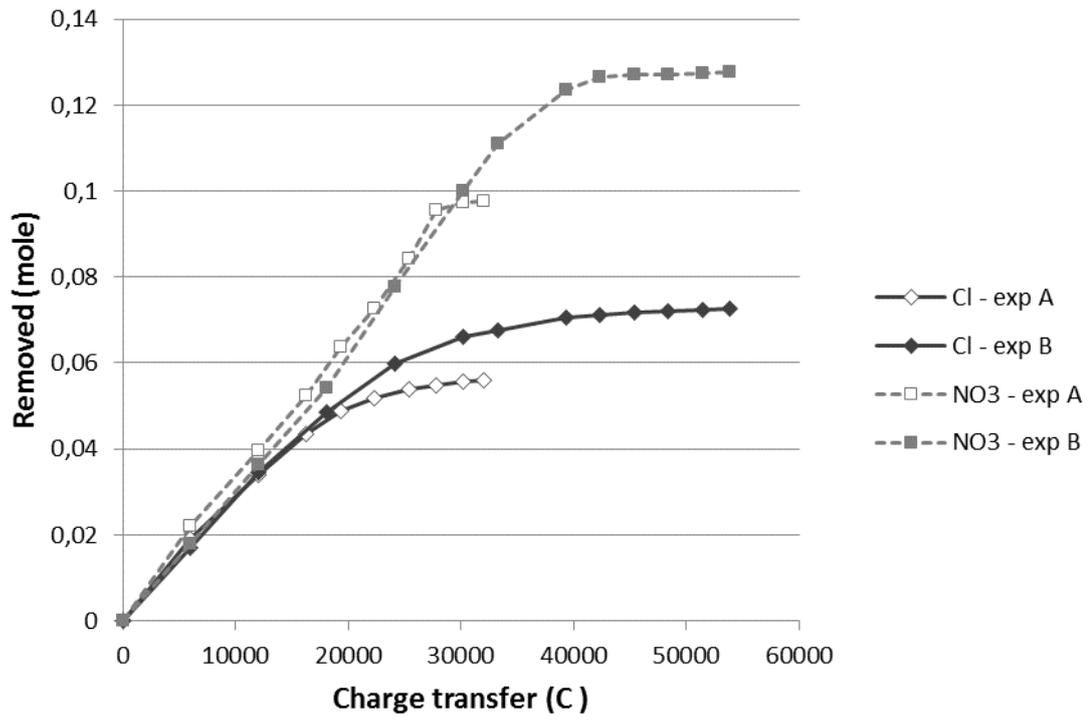
Figure 7

Figure 7: Accumulations of Cl and NO₃ in the anode poultice

The accumulations of Cl^- and NO_3^- in the anode poultice based on the concentrations, which were measured every time the poultice was changed, are shown in figure 7. The desalination develops very similar in the two experiments. In the first period from starting the experiment until about 15000C, the Cl^- removal is linearly related to the charge transfer (R^2 0.992 and 0.997). The slopes for the Cl^- removal curves were very similar in the two experiments (experiment A) $2.8 \cdot 10^{-6}$ mole/C and (experiment B) $2.9 \cdot 10^{-6}$ mole/C. After this first period,

the removal rate slows down and soon after the removal was insignificant. The decrease in Cl^- removal rate is linked to the completion of the chloride removal, as it was seen from figure 6, that the final Cl^- concentrations in the tiles are very low. The pattern for NO_3^- removal is similar, but the period with linearity is longer as the initial molar concentration of NO_3^- is higher. The slopes for both the NO_3^- accumulation curves are $3.3 \cdot 10^{-6}$ mole/C (R^2 0.997 and 0.996). Also the NO_3^- removal slows down after a period, where the removal is concluded.

The theoretical ionic mobility for NO_3^- is $7.4 \cdot 10^{-8}$ $\text{m}^2/(\text{s V})$ and for Cl^- $7.9 \cdot 10^{-8}$ $\text{m}^2/(\text{s V})$, i.e. very similar. However, the removal rate for NO_3^- is found slightly higher at figure 7. The relations between initial molar concentration of NO_3^- and Cl^- are 1.7 and 1.5 in the two experiments. As the initial NO_3^- concentrations are the highest, this influences the mutual relation between the removal rates so marginally more NO_3^- is removed than Cl^- despite the similar ionic mobilities.

The removal into the poultice (figure 7) occurs at the same rate until almost complete desalination. After Cl^- was removed, the resistivity increased and the applied current was decreased from 10 mA to 5 mA. A similar increase in resistivity at the time for completing the NO_3^- removal was not seen, but a more gradual resistivity increase after this phase was found. Had an increase in resistivity been found here as well, it would have been possible to use the

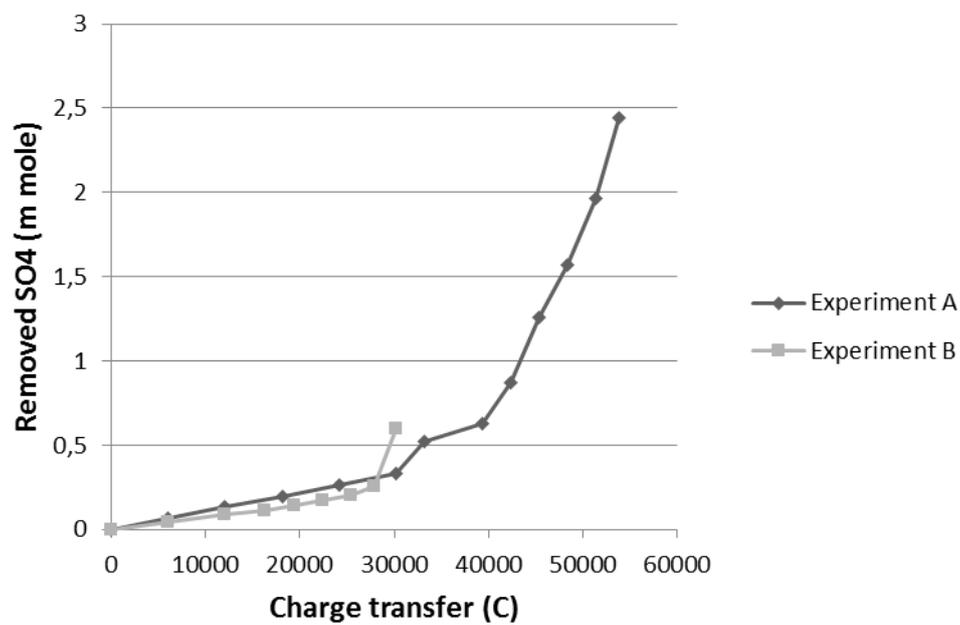
Figure 8

Figure 8: accumulation of SO₄ in anode poultice
