## Fire resistance of extruded hollow-core slabs

*Published in:*  
Journal of Structural Fire Engineering

# Fire resistance of extruded hollow-core slabs

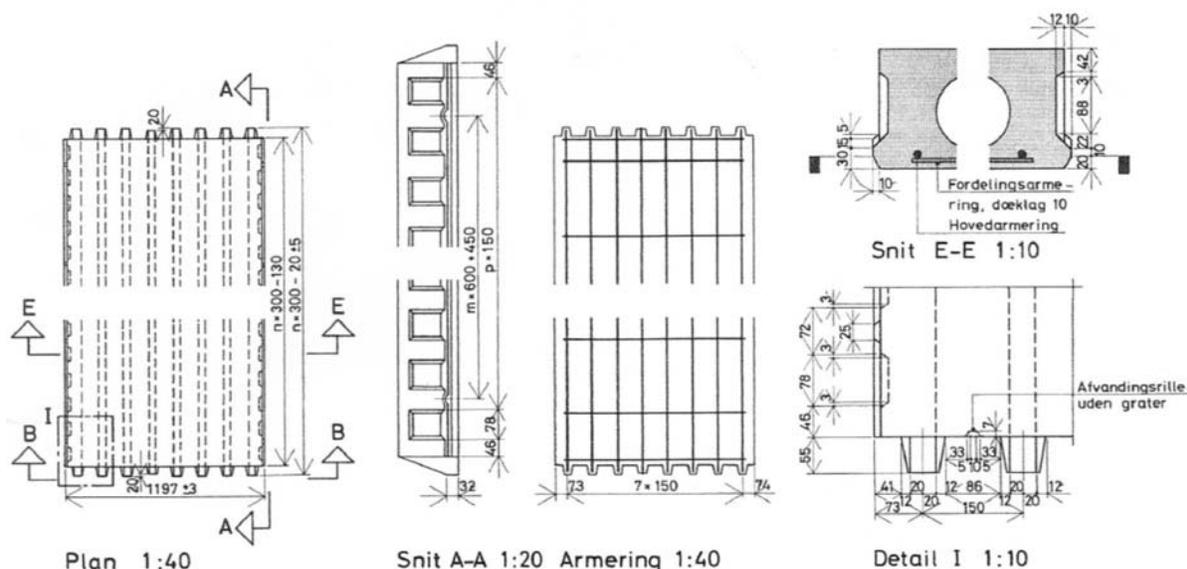
Figure 1. A classic hollow-core slab with slack main reinforcement and transverse reinforcement in the bottom flange [1].

Their geometry and reinforcement are seen on Figure 1 from Nissen [1].

They had slack deformed bars as main reinforcement in the longitudinal direction and slack transverse reinforcement in the bottom flange. This means that the bottom flange under the holes was reinforced across the element, improving the ability to keep the bottom flange in place and transferring horizontal shear.

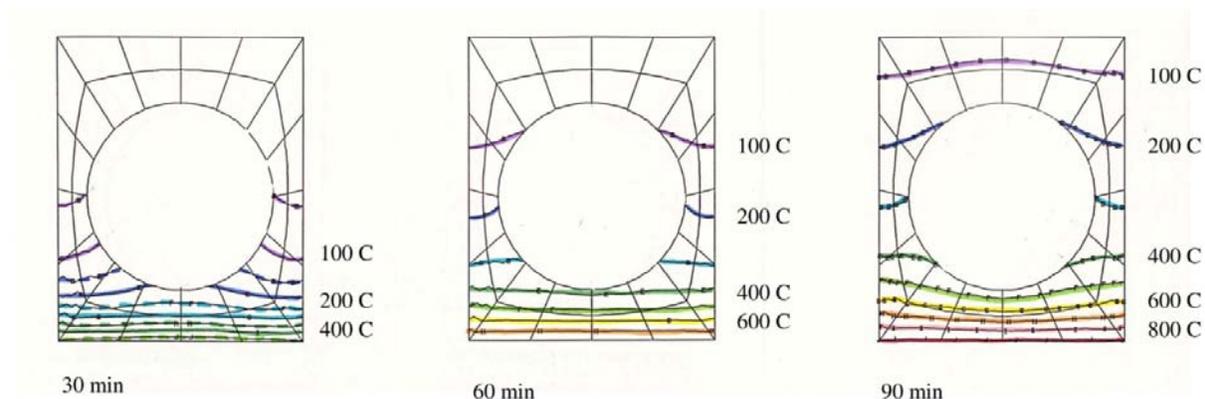
Figure 2. An early example calculation of an isotherm pattern by a 2D FEM analysis.

A number of research results are available on fire exposed hollow-core slabs. An early analytical 2D FEM approach by Poulsen and Schirmacher [2] dealt with the temperature distribution of an original hollow-core slab under the precondition of an unbroken bottom flange (Figure 2).

Integrity of the bottom flange is often assumed for calculating the load-bearing capacity of hollow-core slabs in practise, and results from the corresponding thermal calculations are applied for design, where the isotherms becomes horizontal after 60 minutes like in a massive slab.

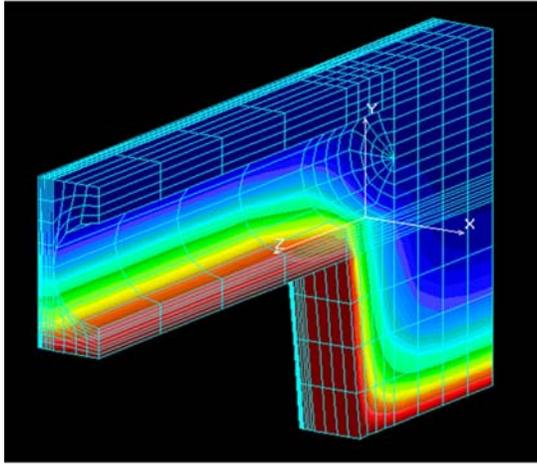
Figure 3. Illustration of a temperature pattern from a 3D FEM analysis at a support.

More recent 3D FEM calculations like the one in Figure 3 (Meaouia [3]) show the same pattern. But in addition, they show temperature distribution at the supports needed for assessment of anchorage properties.

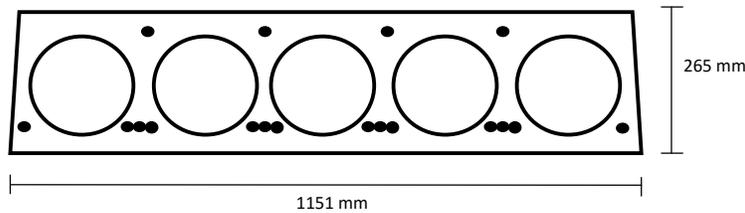
Figure 4. Cross section of extruded hollow-core slab.

This was made in 2004 by the Danish Institute of Fire Technology on two 265 mm thick and 1.2 m wide extruded hollow-core slabs with geometry as seen in Figure 4.

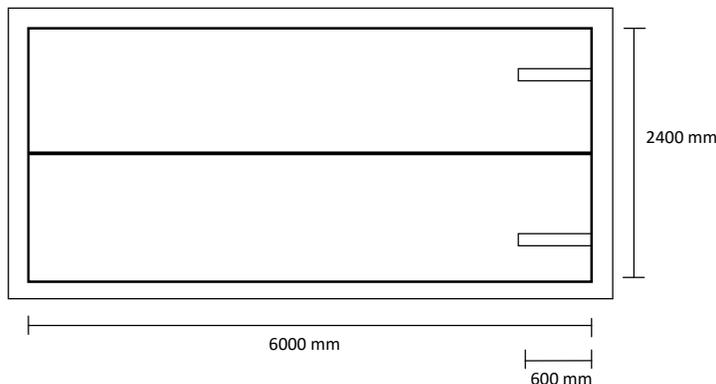
Figure 5. Arrangement of two floor elements in a surrounding frame.

The elements had a span of 6 m between the supports. The groove between the elements was cast out, and the elements were cast into a surrounding frame (Figure 5). The one end of each element was rigidly connected to the frame by casting a 600 mm long reinforcing bar into an opened hole. The concrete quality was 55 MPa, and each element was pretensioned by 14 lines in the bottom and 4 at the top, where each line was 12.5 mm with characteristic tensile strength 1770 MPa. Each element was loaded by 2 pointed loads of 35 kN at 1.783 m from the rigid connected end and 2 of 27 kN at 1.782 m from the other.

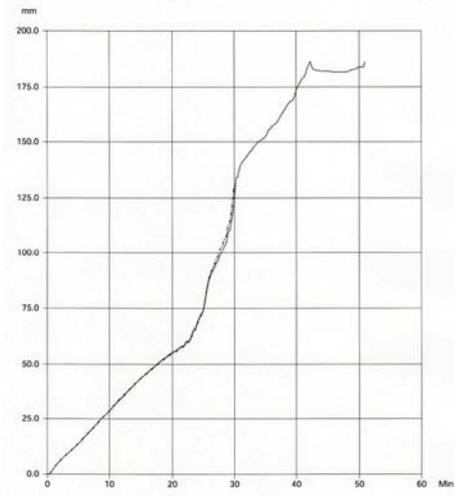
Figure 6. Deflections measured from start of loading.

The midspan deflections are given in Figure 6. Substantial cracks were developed in top and bottom of the slab elements after 15 minutes (Figure 7), and the ISO 834 standard fire duration was assessed to be 25 minutes at this accredited test.

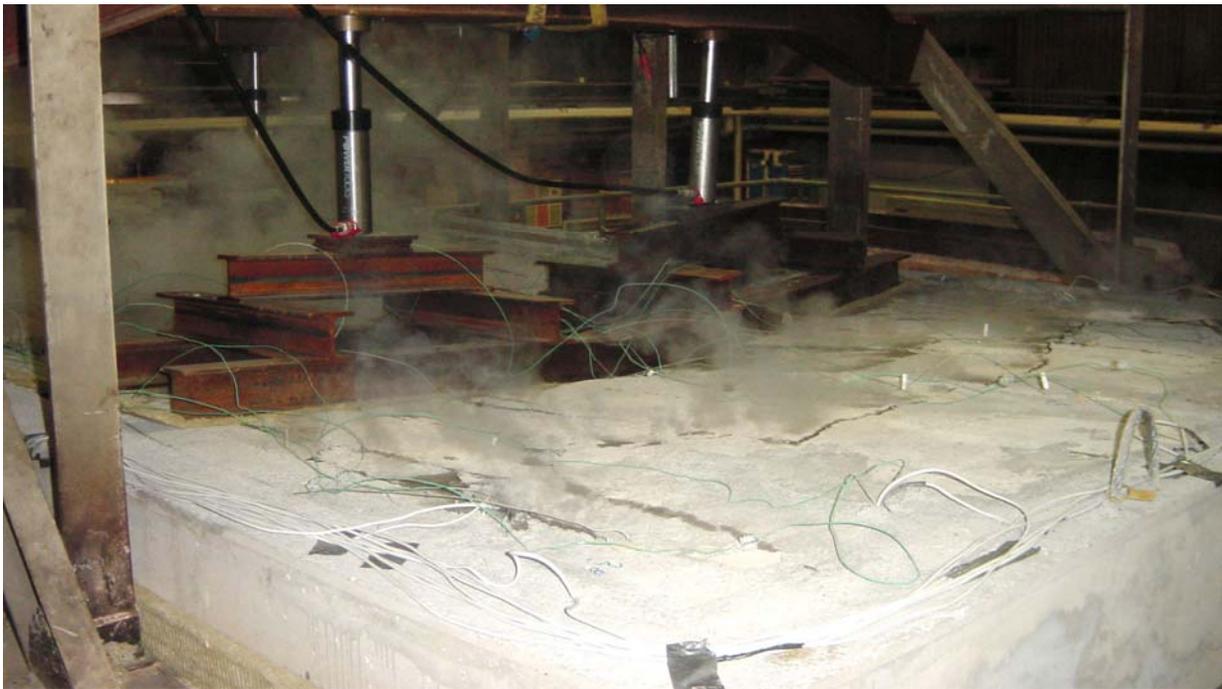
Figure 7. Cracks in top flange after approx. 15 min. Photo K. Hertz.

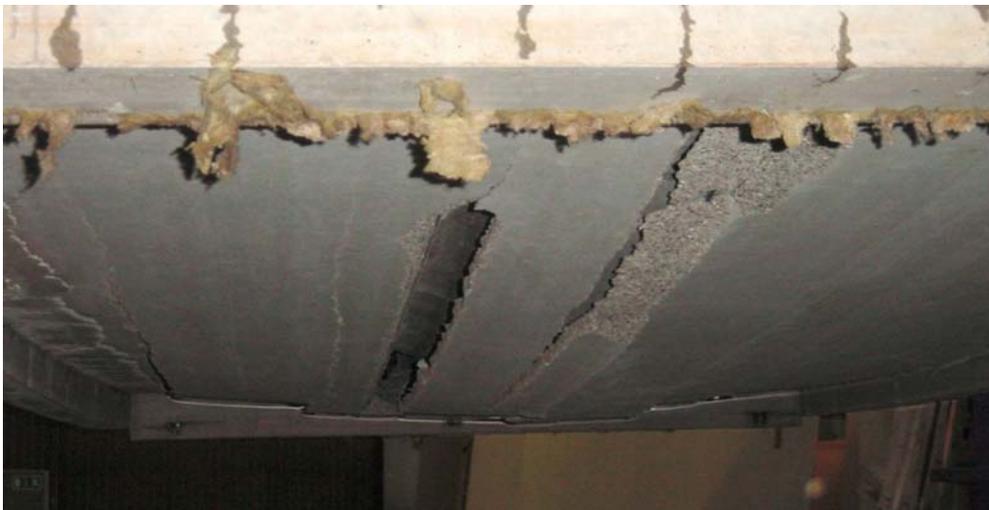
Figure 8. Damages after 25 minutes. Photo K. Hertz.

Lifting the element off the oven, it was seen that the bottom flange was partly fallen down and large cracks were developed to the other channels (Figure 8). No sign of shear failure was seen and the deflection indicated that the failure mode may have been bending. But as explained in the following, the failure modes of shear, anchorage, bending, and de-lamination may be results of the same deterioration of the slab.

Cracks appear along the decks under the channels after 10-15 minutes fire exposure and often the bottom flanges falls down, as shown for example in Figure 8.

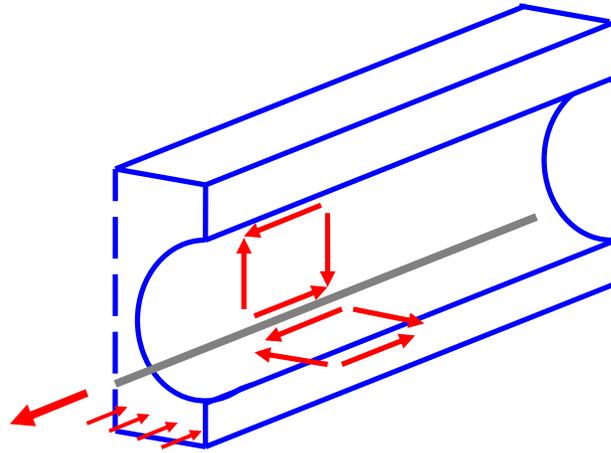
Figure 9. Shear stresses in web and bottom flange.

Nevertheless, a short element cannot develop the same bending induced horizontal shear between web and the bottom flange beneath the longitudinal holes, as a long element (Figure 9). The mechanical and the thermal deflections are not the same for a short as for a long element. It is therefore obvious that a test of a short element cannot show the same effect of loss of integrity of the bottom flange, and such a test can therefore not document how the shear resistance of the web between the holes is affected in a longer hollow-core slab exposed to fire.

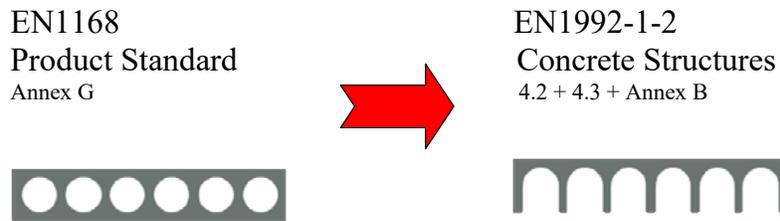
Figure 10. Reduced cross-section for simplified calculations.

Due to the short time before the integrity of the bottom flange is lost, a reasonable simplified calculation will be to omit the bottom flange at the holes and consider the ribs between the holes as exposed by fire from 3 sides from the beginning of the fire as shown in Figure 10.

Figure B5b in EN 1992-1-2 [4] (Figure 11) shows that the damaged zone  $a_z$  for a slab with a thickness of 150-250 mm is 36 mm after a 120 minutes standard fire and 20 mm for a 60 minutes standard fire. This means that the bottom flange of a hollow-core slab, which is usually about 34 mm thick, will be completely covered by the damaged zone after 120 minutes and the majority of it after 60 minutes. This means that the reduced cross-section to be considered according to concrete code EN 1992-1-2 [4] is a ribbed cross-section, because the damaged unreinforced bottom flange cannot be taken into account under the holes, where there is nothing to support it (Figure 10).

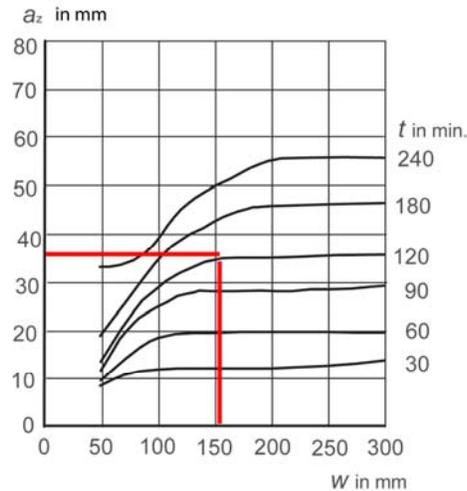
Figure 11. Damaged zone in mm after 120 min (fig B5b in EN1992-1-2).

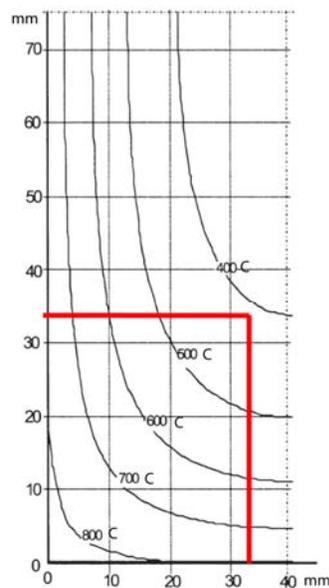
Figure 12. Temperature after 30 min in depth 34 mm (fig A3 in EN1992-1-2).

The prestressing tendons in an extruded hollow-core slab will often have a depth to the centre line of 34 mm. A finite difference temperature calculation as Confire [16] of the temperature of a prestressing tendon with cover 34 mm from the bottom in an 80 mm thick web gives  $444^{\circ}\text{C}$  after 30 minutes of a standard fire, where the 0.2% yield strength of a cold-drawn prestressing wire is reduced to 25% of its original value and the load-bearing capacity in bending must be regarded as insufficient. If the temperature were instead assessed by figure A3 in the Eurocode [4], a temperature of  $420^{\circ}\text{C}$  would be obtained (Figure 12).
