Thermal properties of Fiber ropes

Citation (APA):
Bossolini, E., Nielsen, O. W., Oland, E., Sørensen, M. P., & Veje, C. (2016). Thermal properties of Fiber ropes. Paper presented at European Study Group with Industry, ESGI, Denmark.

Thermal Properties of Fiber Ropes

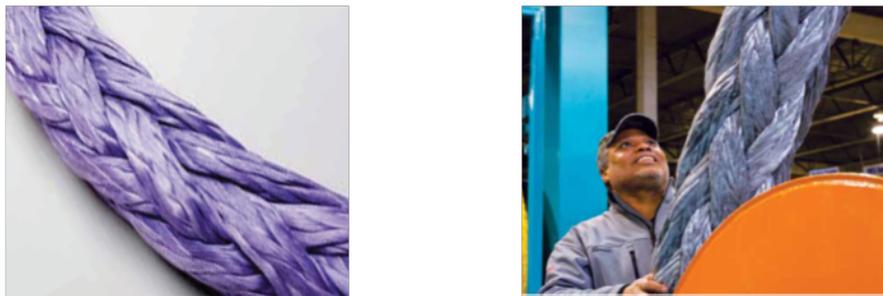
Figure 1: Cortland Plasma 12x12 rope (left) and the world's largest 12x12 rope (right).

Fiber ropes consist of several strands that braided into a rope. Cortland Plasma¹ 12x12 is a rope made of High Modulus Polyethylene (HMPE) and consists of 12 strands that are braided into 12 subropes, which again are braided together into one very strong rope. Figure 1 shows the construction of a Cortland Plasma 12x12 rope and an example of how big such a rope can be made.

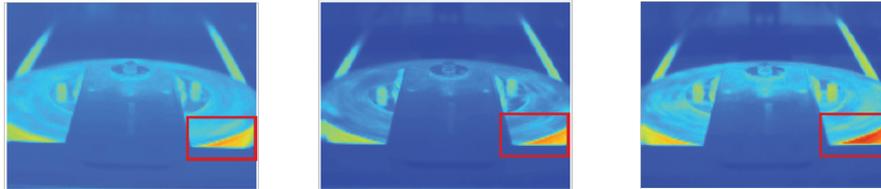
Figure 2: Infrared images of a rope bent over a sheave [2]. The remaining useful life is the largest to the left and decreases towards the right. Notice how the temperature increases as the RUL decreases.

will continue until the rope is discarded or become severed when the load exceeds its load-bearing capabilities (which are reduced due to melted fibers). One of the most important parameters to monitor for fiber ropes is the temperature, suggesting that a thermographic camera might be a good tool for condition monitoring. Experimental results suggest that there is a relation between the temperature of a fiber rope and its remaining useful life (RUL), something that is illustrated in Figure 2.

1. It is desirable to use thermography for monitoring the temperature inside the rope. Figure 2 shows the surface temperature, while measurement of the internal temperature requires embedded sensors. From a modeling perspective, how is the temperature inside the rope relative to what you obtain from the thermographic image, and can this be used to create a simple tomographic model? (Mapping from surface to internal)

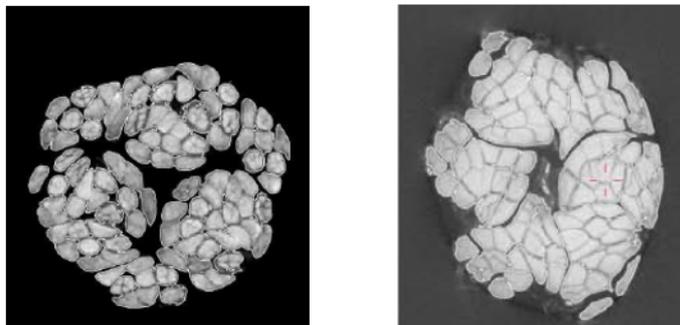
Figure 3: X-ray of a braided rope before (left) and after testing (right) [1]. Notice how the fibers have been fused together changing the structure and making a more dense rope. The figures are not to scale.

The internal structure of the fiber rope becomes changed over time as the rope is heated and cooled in a cyclic manner. Figure 3 shows the internal structure of a braided rope before and after use. It is obvious that the structure is changed as the fibers melt together, thereby changing the thermal properties of the rope itself, something that can be detected using thermography.

2. How is the *change* in temperature as a point on the rope moves away from the sheave? Due to structural changes (*cf.* Figure 3), the heat dissipation is expected to be different between a new rope and an old rope. Can this be used to better describe the condition of the rope than static images?

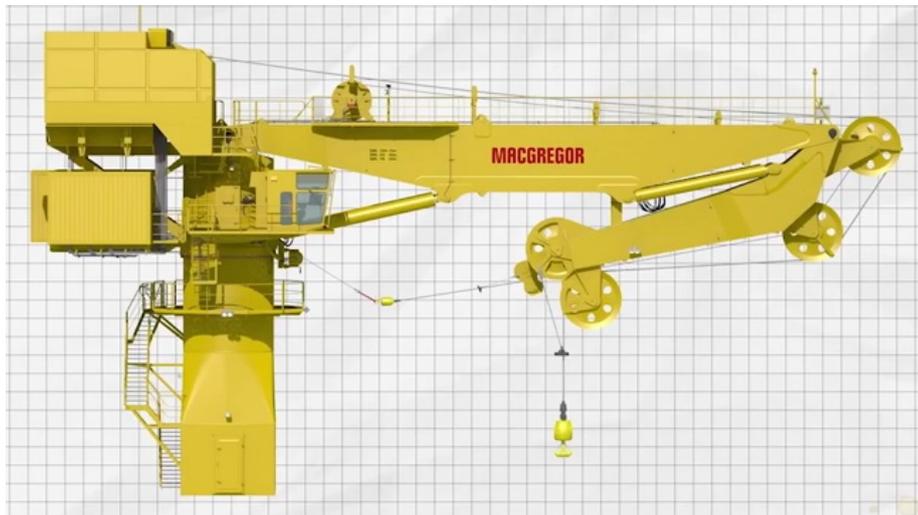
Figure 4: On a crane used for heave compensation, it is the sheaves that have the most impact on the remaining useful life of the fiber ropes.

A crane contains many sheaves to control the rope, something that is shown in Figure 4. During heave compensation, the rope is moved back and forth over these sheaves, generating much heat, and this is the main cause of deterioration for the rope. Figure 5 shows how the temperature increases as the rope is bent over a sheave, making monitoring of the sheaves on a crane the most critical points when doing condition monitoring. Figure 5 also shows that it is not the friction towards the sheave that generates the heat, but it is the internal abrasion between the strands in the rope that generates the heat, which melts and deteriorates the rope.

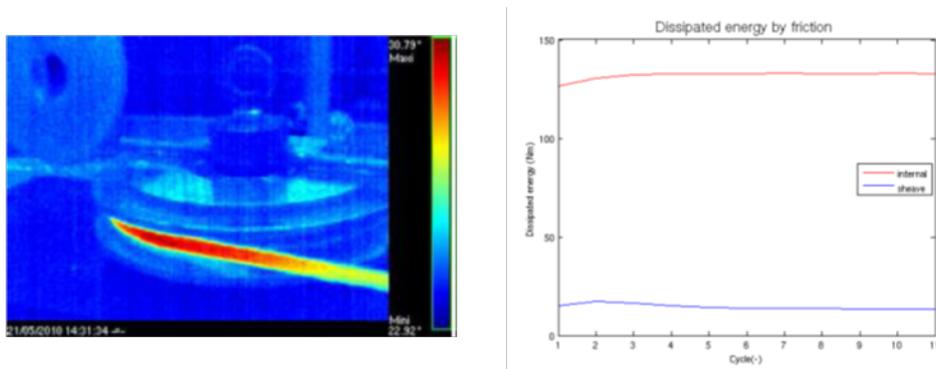
Figure 5: Thermal image during cyclic bend over sheave (left) and the dissipated energy during cycling (right) [1]. The external friction coefficient (towards the sheave) is 0.1, while the internal friction coefficient (between strands) is 0.03. Notice that it is the internal friction (red line) that generates most of the heat.
