Proceedings of the European Corrosion Congress 2012

Effect of Ionic Contamination on Corrosion Reliability of Printed Circuit Board Assemblies

Vadimas Verdingovas, Morten Stendahl Jellesen, and Rajan Ambat
Materials and Surface Engineering, Department of Mechanical Engineering,
Technical University of Denmark, DK-2800 Lyngby, Denmark
vaver@mek.dtu.dk

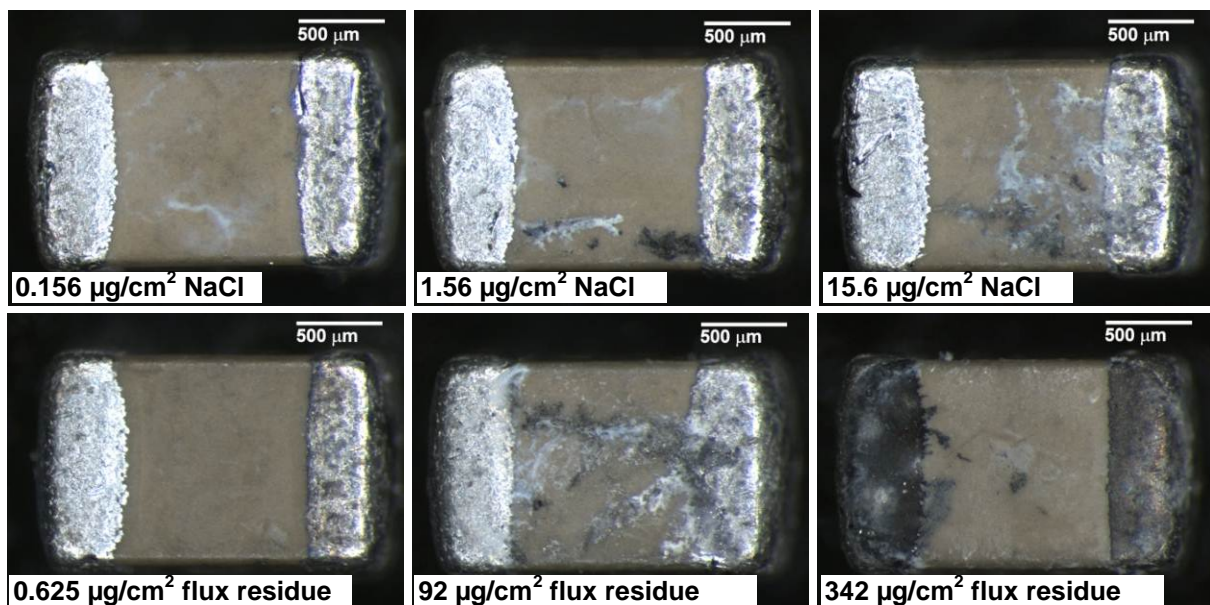
Figure 5 shows the morphology of the dendrite after migration for NaCl and flux residue as a function of concentration. For NaCl, the probability of dendrite growth increases rapidly above a concentration of $0.858 \mu\text{g}/\text{cm}^2$. Below this level, the migration probability is low, probably due to the low dissolution of tin. Typical surface morphology of a component at $0.156 \mu\text{g}/\text{cm}^2$ of NaCl shows very few corrosion products (appearing white in the image). However as the concentration of chloride increases, dendrites start appearing, and at very high concentration levels a mixture of dendrites and white precipitate species can be seen. At high chloride levels, the probability of ECM is also slightly reduced due to the large amounts of tin ions in the solution which leads to heavy precipitation, reducing the chance for dendrite growth as reported by Minzari et al. [13]. The precipitated species can be hydroxides of tin namely $\text{Sn}(\text{OH})_4$ and/or $\text{Sn}(\text{OH})_2$, although intermediate hydroxyl chloride species are also possible [14].

Figure 5: Size 0805 capacitors after SCECM testing at 5 V DC; pictures corresponding to NaCl and solder flux residues are shown in the images. Anode terminal is on the right and cathode on the left side

Typical optical micrographs of the tested components with flux residue (**Figure 5**) shows that the level of corrosion is negligible at lower concentrations; however, at $92 \mu\text{g}/\text{cm}^2$, the surface of the component shows a clear dendrite mixed with some hydroxides. The appearance of ECM at flux residue concentrations $3.75 \mu\text{g}/\text{cm}^2 - 92 \mu\text{g}/\text{cm}^2$ is similar to the appearance of ECM observed with NaCl. Light optical microscope images revealed the dendrites (dark grey color) bridging the terminals and the tin hydroxides (white color).

Further increase in flux residue concentrations caused only a low probability of migration (**Figure 3 (b)**), while the component shown in **Figure 5** shows heavy corrosion of the anode terminal, but no dendrites or precipitation of tin hydroxides as was seen in the case of NaCl. This appearance might indicate that the pH level of solution was moved towards the acidic area due to the high levels of weak organic acids in the flux residue and therefore the precipitation of tin hydroxides was

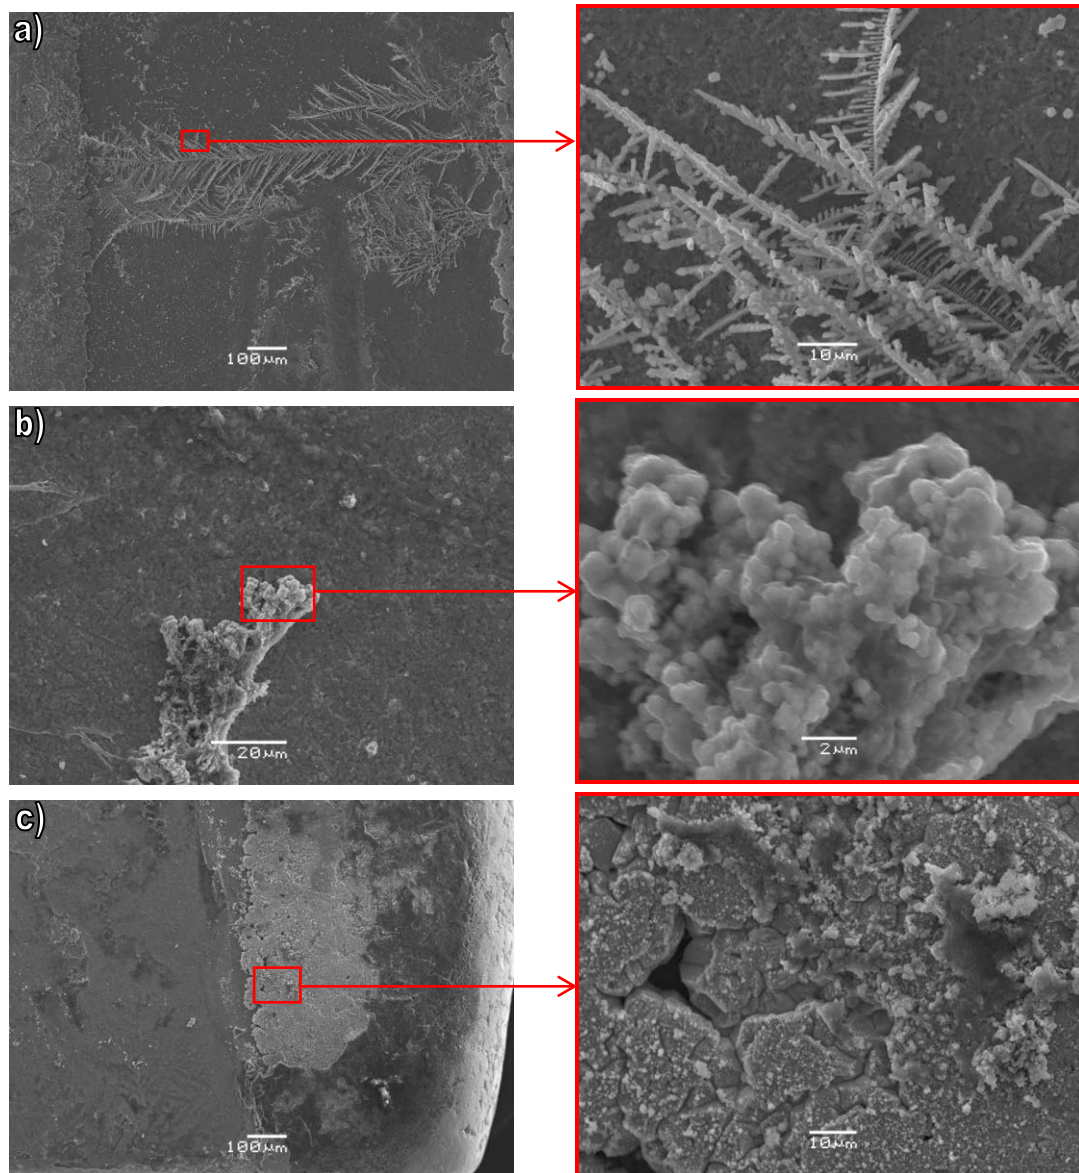
Figure 6: (a) – ECM on the size 0805 capacitors with $92 \mu\text{g}/\text{cm}^2$ of flux residue; (b) – deposition of corrosion product (black deposits) nearby cathode terminal with $342 \mu\text{g}/\text{cm}^2$ of flux residue and (c) – corrosion of anode terminal with $342 \mu\text{g}/\text{cm}^2$ of flux residue

The EDS analysis of corrosion products on the anode terminal (**Figure 6 (c)**) indicated mainly tin (85 wt.%, however some amount of copper (10 wt.%) and small amount of chromium (less than 5 wt.%) were identified. Both elements are known to be used as termination materials for multilayer chip capacitors [17–19], and indicate a heavy dissolution of electroplated top layer of tin. The copper and chromium were mostly

identified on the very edges of the anode terminal, where the dissolution rate of metal is expected to be the highest.

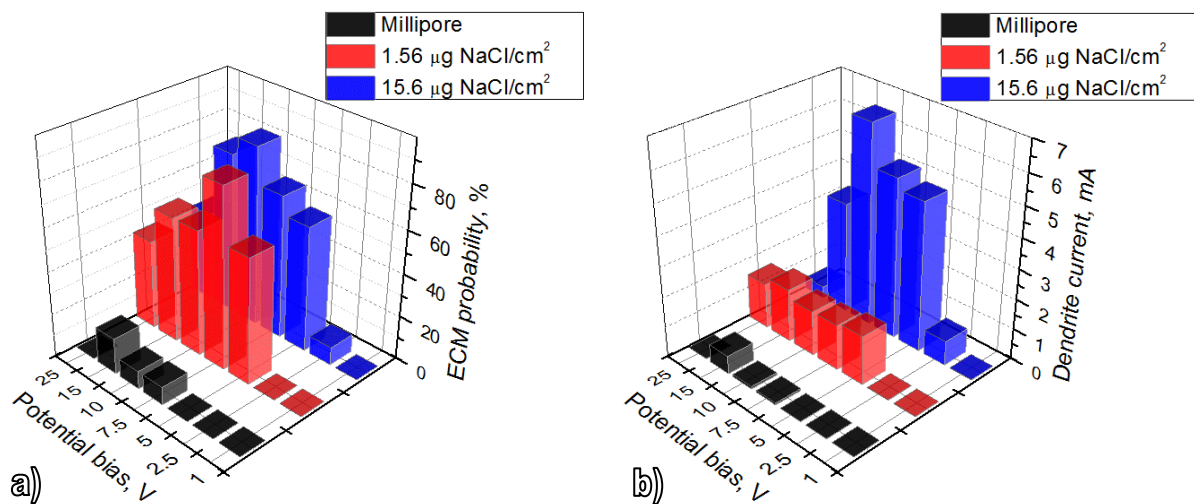
Figure 7: (a) – Comparison of the potential influence on ECM probability and (b) – dendrite current in terms of contamination

In general the probability of migration shows a bell curve with an increasing trend initially followed by a decreasing trend above the maximum, similar to the result found for increase in concentrations of contaminants. However, **Figure 7 (a)** shows

that the effect of contamination is more pronounced, especially from Millipore water to $1.56 \mu\text{g}/\text{cm}^2$ chloride solutions. The dendrite current also shows a similar behavior except for a large increase of dendrite current at $15.6 \mu\text{g}/\text{cm}^2$ conditions. This indicates the formation of thick dendrites, unlike in other cases. It shows that increased contamination increases the dissolution rate of the metal, which consequently forms thicker and more branched dendrites containing more metal and hydroxide precipitation. The high amount of metal content in the dendrites increases the current leaking through. However, as the potential increases, the probability of migration decreases, which also correlates with a decrease in the dendrite current. This is due to the fact that the rate of dissolution of tin increases with an increase in potential bias similar to increase in contamination. This leads to precipitation of the hydroxide species, while the heavy gas evolution at the anode and cathode also inhibit the formation of dendrites. Minzari et al. [11] have reported similar phenomenon with increase in potential bias or contamination level.

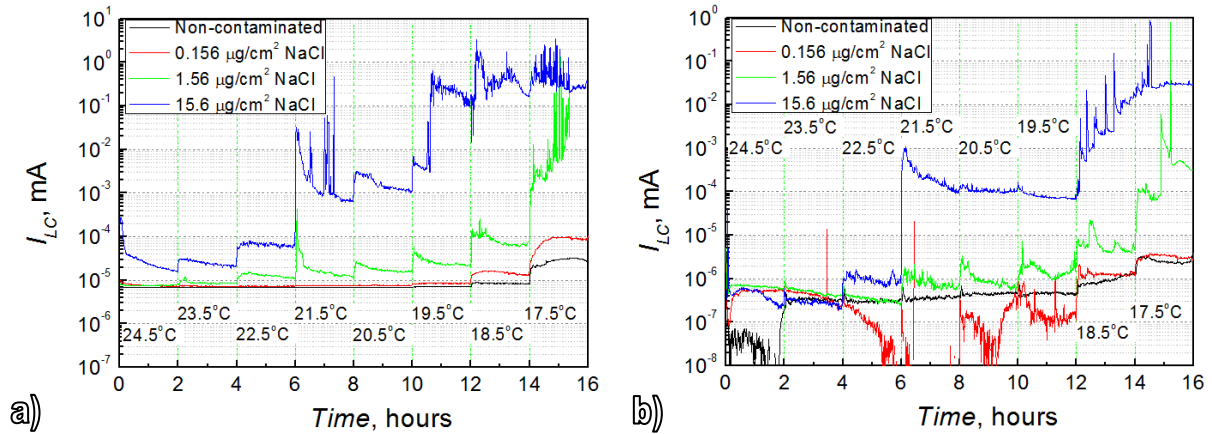
The effect of temperature difference between the PCB surface and surrounding air on the water condensation and leak current was studied on 10 surface mount ceramic chip capacitors connected in parallel and the SIR comb pattern biased at 5 V DC. The temperature of surrounding air has been kept constant at 25 °C. The leak current curves presented in **Figure 9** indicate the increase of current with increased difference in temperature of surrounding air and the surface of the PCB. The temperatures listed on the graphs are the average values of temperatures obtained with two RTD sensors places on the surface of the test PCB.

Figure 9: Leakage current measured on test PCB biased at 5 V DC (a) – SIR comb pattern and (b) – 10 ceramic chip capacitors size 0805 connected in parallel

For the non-contaminated condition, the increase of current is very little and it occurs during the last two steps, when the temperature difference between the surrounding air and PCB is sufficient enough for water condensation to occur. The increase of leakage current at $0.156 \mu\text{g}/\text{cm}^2$ of NaCl occurs at the same steps as it was on a non-contaminated surface, but with slightly higher magnitude of current.
