Proceedings of the European Corrosion Congress 2012

# Effect of Ionic Contamination on Corrosion Reliability of Printed Circuit Board Assemblies

*Vadimas Verdingovas, Morten Stendahl Jellesen, and Rajan Ambat*  
*Materials and Surface Engineering, Department of Mechanical Engineering,*  
*Technical University of Denmark, DK-2800 Lyngby, Denmark*  
[vaver@mek.dtu.dk](mailto:vaver@mek.dtu.dk)

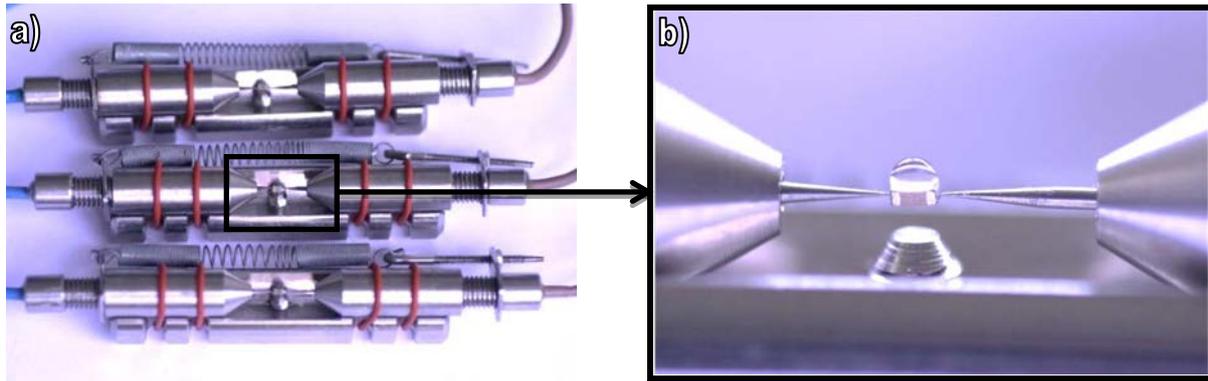
Single component electrochemical migration tests have been conducted using a special setup described by Minzari et al. [10,11]. The single component electrochemical migration (SCECM) setup consists of a sample holder having two small adjustable probes, which act as connectors to each end of the surface mount components (SMC) – in this case ceramic chip capacitors. The entire SCECM setup consists of three separate pairs of metal probes and enables the experiments to be conducted with three chip capacitors at a time, as shown in **Figure 1 (a)**.

**Figure 1:** Single component electrochemical migration setup

The ECM probability testing on the single components was done by placing a micro droplet of electrolyte at a desirable concentration on top of the surface mount components. The current was measured between the terminals of the components which are bridged via the droplet of electrolyte solution and biased at DC voltage in the range of 1 V – 25 V using an in-house built multi-channel multiplexer unit called “CELCORR test PCB set up”, described elsewhere [12]. The leak current followed by the current increase due to ECM (electric short due to dendrite formation) was measured with a 1  $\mu$ A resolution ammeter connected in the circuit via a two switch system. The sampling rate for the leakage current reading was set to 1 s. The experiments were carried out under ambient conditions: temperature 23.5°C – 24.5°C, relative humidity 30% – 40%.

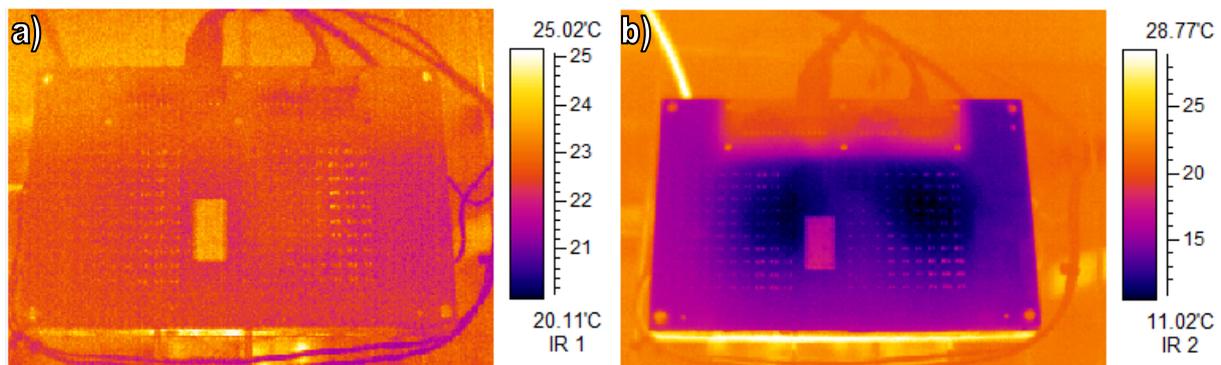
The temperature of the PCB was controlled by mounting the PCB on an aluminum block with embedded Peltier elements. The heat from the hot side of the Peltier elements was removed using a coolant passing through the hollow aluminum block. A DC power source (EA-PSI 6032-06 32V/6A) was used for applying potential to the Peltier elements. The surface temperature of the PCB mounted on the aluminum block was measured with two platinum Resistance Temperature Detectors (PT1000 class A) connected in a 2-wire circuit. DaqLink data logger “Fourier Systems DBSA720” was used to log the temperature/voltage readings on the surface of PCB throughout the duration of the experiment. The cooling effect on PCBs placed on the aluminum block is presented in **Figure 2**.

**Figure 2:** Temperature profiles of test PCB fixed on aluminum block with embedded Peltier elements taken at ambient temperature of 25°C: (a) – without cooling; (b) – 4V DC is applied on Peltier elements

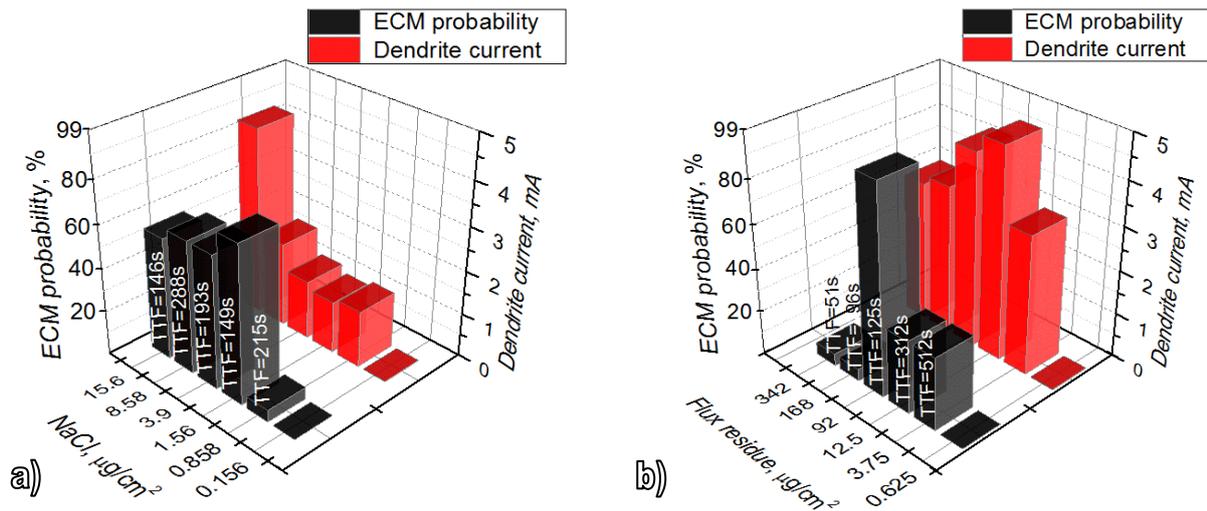
**Figure 3** shows the probability of migration (number of capacitors which showed ECM out of 18 experiments in each category expressed as a percentage) and the average dendrite current for NaCl and flux residue as a function of concentration. The average time to dendrite growth initiation marked as time to failure (TTF) corresponding to each set of experiments is shown on the bar.

**Figure 3:** ECM probability and dendrite current as a function of concentration: (a) NaCl and (b) flux residue

Further increase in flux residue concentrations caused only a low probability of migration (**Figure 3 (b)**), while the component shown in **Figure 5** shows heavy corrosion of the anode terminal, but no dendrites or precipitation of tin hydroxides as was seen in the case of NaCl. This appearance might indicate that the pH level of solution was moved towards the acidic area due to the high levels of weak organic acids in the flux residue and therefore the precipitation of tin hydroxides was

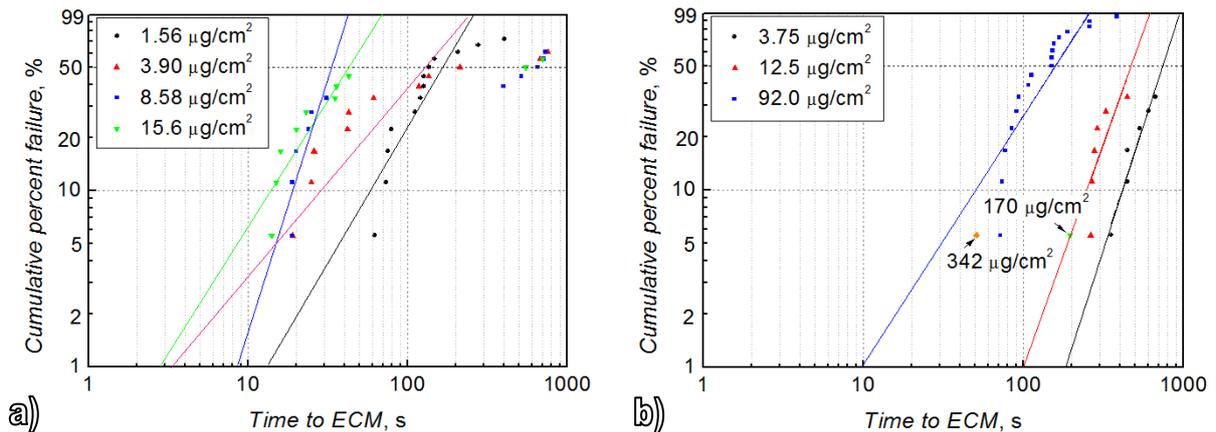
The level and the type of ionic contamination showed an influence on the probability of an ECM event and also the time of ECM initiation. The following effects are shown in the cumulative percent of ECM versus time graphs for NaCl and solder flux residues in **Figure 4**.

**Figure 4:** Cumulative failure dependence of time for (a) – NaCl and (b) – solder flux residue

As is seen from the graphs in **Figure 4**, increasing concentration shortens the time to an ECM event. This fact is also clear from the comparison of the time needed for 50 % of capacitors to show ECM as well as from the time to the first failure. In the case of NaCl, the increase of concentration from  $1.56 \mu\text{g}/\text{cm}^2$  to  $15.6 \mu\text{g}/\text{cm}^2$  reduces the time to first failure accordingly: 62s, 25s, 19s and 14s. The presence of flux residues reduces the time to the first ECM event from 354s to 72s with increase of concentration from  $3.75 \mu\text{g}/\text{cm}^2$  to  $92 \mu\text{g}/\text{cm}^2$ .

The results revealed contamination levels below which the probability of dendrite growth is very low. This empirically found limit for NaCl is in the range between  $1.56 \mu\text{g}/\text{cm}^2$  and  $0.858 \mu\text{g}/\text{cm}^2$ , whereas for “no-clean” solder flux residues investigated in this work, this limit is much more broad where it starts at  $3.75 \mu\text{g}/\text{cm}^2$  until it peaks around  $92 \mu\text{g}/\text{cm}^2$ . In general a decrease of TTF and to some extent an increase of cumulative percent failure was observed with increasing level of contamination (**Figure 4**). However a considerable reduction of ECM probability at very high

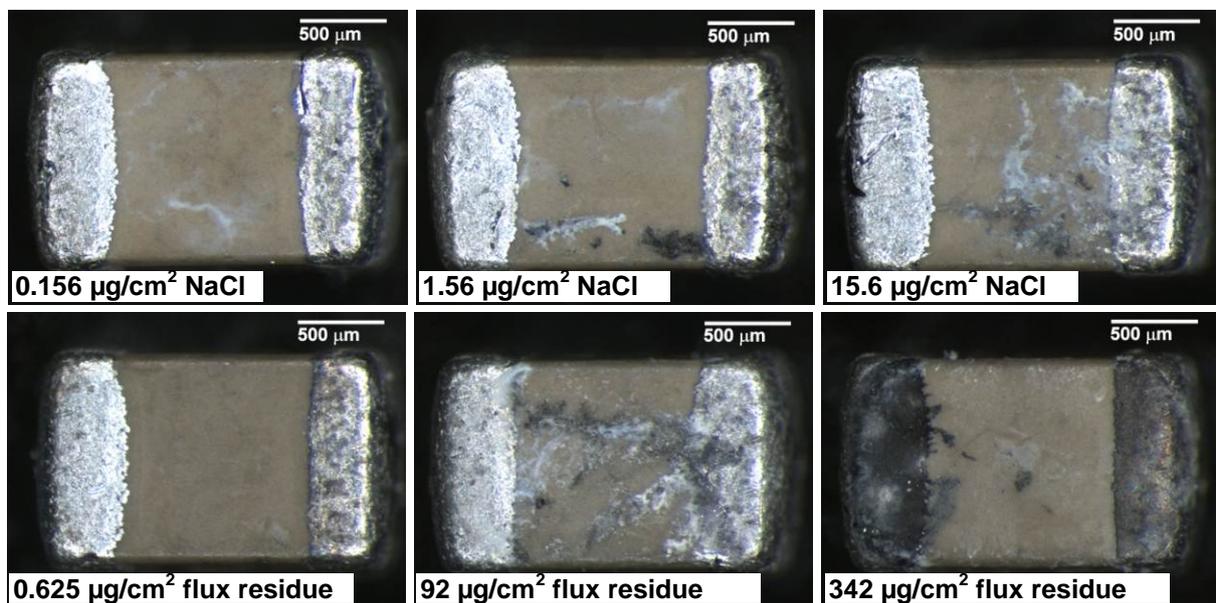
**Figure 5** shows the morphology of the dendrite after migration for NaCl and flux residue as a function of concentration. For NaCl, the probability of dendrite growth increases rapidly above a concentration of  $0.858 \mu\text{g}/\text{cm}^2$ . Below this level, the migration probability is low, probably due to the low dissolution of tin. Typical surface morphology of a component at  $0.156 \mu\text{g}/\text{cm}^2$  of NaCl shows very few corrosion products (appearing white in the image). However as the concentration of chloride increases, dendrites start appearing, and at very high concentration levels a mixture of dendrites and white precipitate species can be seen. At high chloride levels, the probability of ECM is also slightly reduced due to the large amounts of tin ions in the solution which leads to heavy precipitation, reducing the chance for dendrite growth as reported by Minzari et al. [13]. The precipitated species can be hydroxides of tin namely  $\text{Sn}(\text{OH})_4$  and/or  $\text{Sn}(\text{OH})_2$ , although intermediate hydroxyl chloride species are also possible [14].

**Figure 5:** Size 0805 capacitors after SCECM testing at 5 V DC; pictures corresponding to NaCl and solder flux residues are shown in the images. Anode terminal is on the right and cathode on the left side

Typical optical micrographs of the tested components with flux residue (**Figure 5**) shows that the level of corrosion is negligible at lower concentrations; however, at  $92 \mu\text{g}/\text{cm}^2$ , the surface of the component shows a clear dendrite mixed with some hydroxides. The appearance of ECM at flux residue concentrations  $3.75 \mu\text{g}/\text{cm}^2 - 92 \mu\text{g}/\text{cm}^2$  is similar to the appearance of ECM observed with NaCl. Light optical microscope images revealed the dendrites (dark grey color) bridging the terminals and the tin hydroxides (white color).

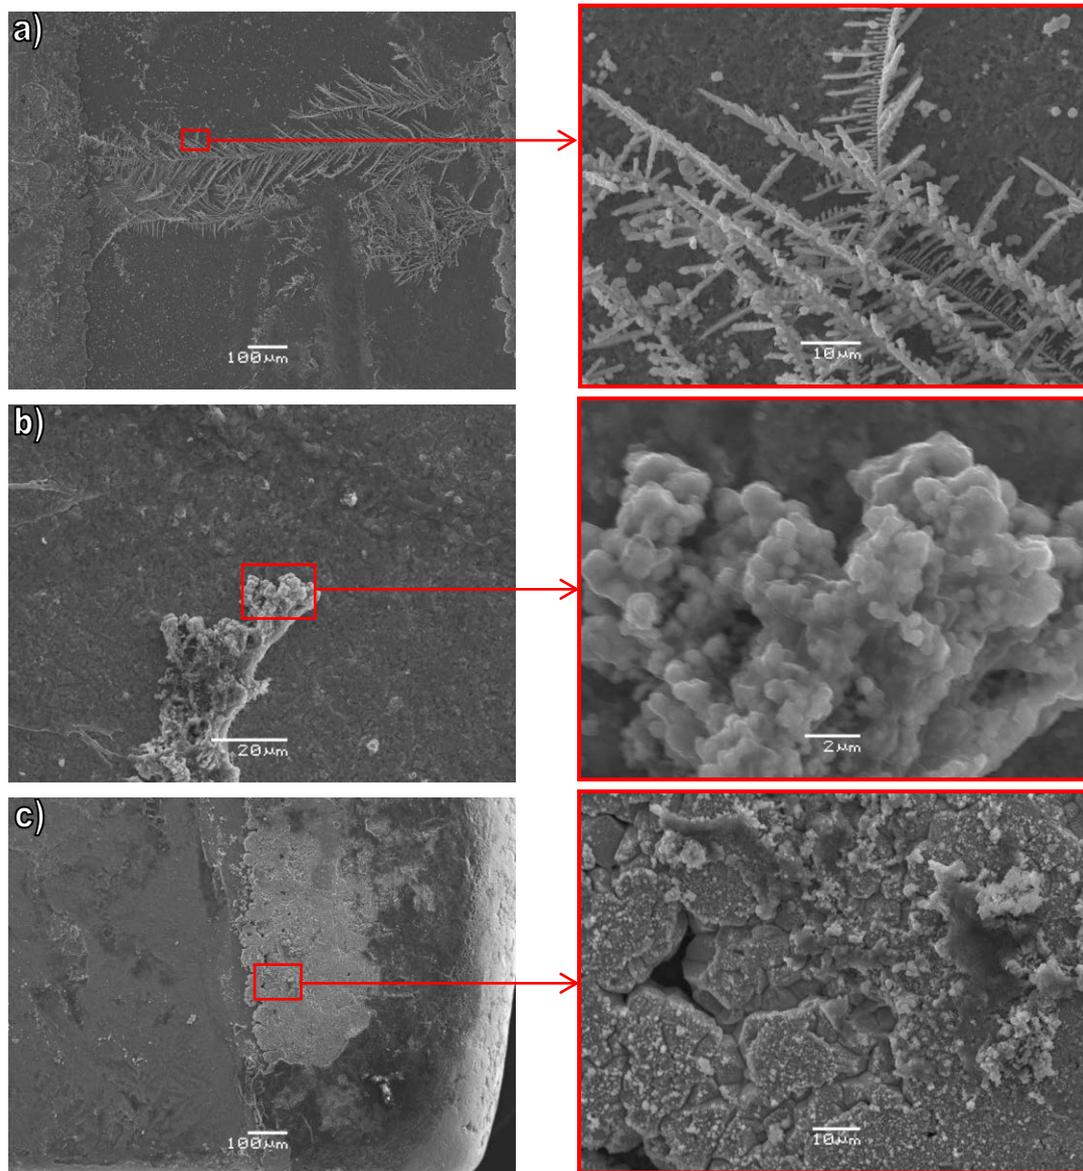
thermodynamically unfavorable. According to the appearance of the capacitors, all the metal dissolved on the anode migrated towards the cathode and deposited there as an oxide or hydroxide; however, the dissolution, migration and precipitation of copper ions is also likely. It is known that the precipitation of tin as an oxide or hydroxide can create a passive film (cassiterite  $\text{SnO}_2$ ) [15] for which the stability increases with dehydration of the tin hydroxides [16]. The appearance of black deposits near the cathode is shown in **Figure 6 (b)**. The EDS analysis of composition of black deposits showed high content of tin (65 wt.%) and oxygen (30 wt.%), and small amount of copper (5 wt.%).

**Figure 6:** (a) – ECM on the size 0805 capacitors with  $92 \mu\text{g}/\text{cm}^2$  of flux residue; (b) – deposition of corrosion product (black deposits) nearby cathode terminal with  $342 \mu\text{g}/\text{cm}^2$  of flux residue and (c) – corrosion of anode terminal with  $342 \mu\text{g}/\text{cm}^2$  of flux residue

The EDS analysis of corrosion products on the anode terminal (**Figure 6 (c)**) indicated mainly tin (85 wt.%, however some amount of copper (10 wt.%) and small amount of chromium (less than 5 wt.%) were identified. Both elements are known to be used as termination materials for multilayer chip capacitors [17–19], and indicate a heavy dissolution of electroplated top layer of tin. The copper and chromium were mostly

identified on the very edges of the anode terminal, where the dissolution rate of metal is expected to be the highest.

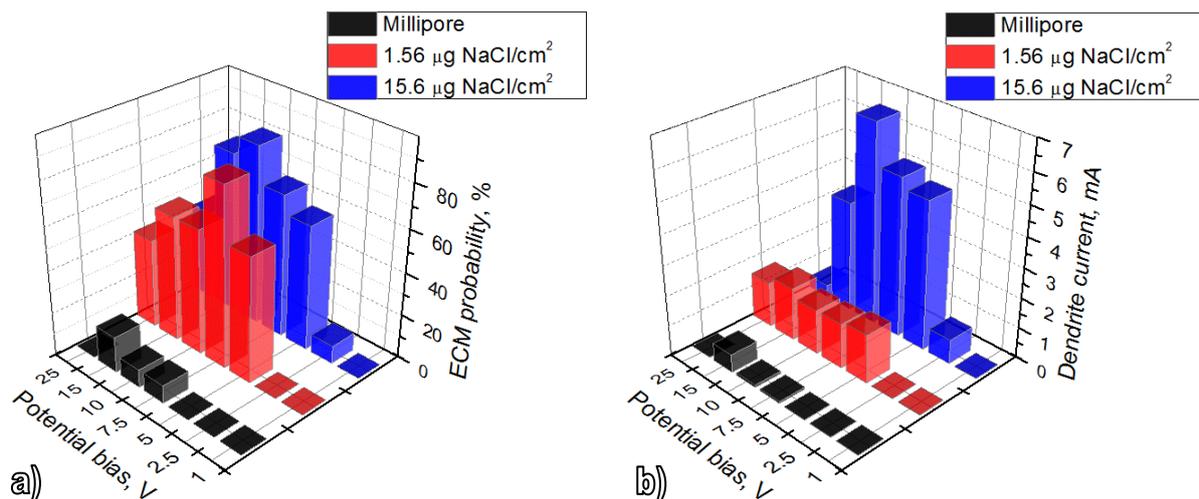
The effect of electric field in the range between  $1 \text{ mV}/\mu\text{m}$  and  $25 \text{ mV}/\mu\text{m}$  on ECM probability and dendrite current was investigated at contamination levels  $1.56 \mu\text{g}/\text{cm}^2$  and  $15.6 \mu\text{g}/\text{cm}^2$  concentrations of NaCl together with clean components. The graphs representing the results are shown in **Figure 7**. It is seen that the probability of migration initially increases with increasing electric field as the voltage applied on the terminals of capacitor until an intermediate voltage is reached, after which an increase in voltage causes a decrease in the probability of electrochemical migration. The electric field at which maximum probability of migration occurs is a function of NaCl concentration, however it was found to be in the neighborhood of  $10 \text{ mV}/\mu\text{m}$  –  $15 \text{ mV}/\mu\text{m}$  (respectively  $10 \text{ V}$  and  $15 \text{ V}$  potential bias). Also the probability of migration in general was low at lower potential bias values such as  $1 \text{ V}$  –  $2.5 \text{ V}$  above which the probability increases drastically in solutions containing NaCl, while the probability of migration in Millipore water remains low irrespective of the potential bias.

**Figure 7:** (a) – Comparison of the potential influence on ECM probability and (b) – dendrite current in terms of contamination

In general the probability of migration shows a bell curve with an increasing trend initially followed by a decreasing trend above the maximum, similar to the result found for increase in concentrations of contaminants. However, **Figure 7 (a)** shows

that the effect of contamination is more pronounced, especially from Millipore water to  $1.56 \mu\text{g}/\text{cm}^2$  chloride solutions. The dendrite current also shows a similar behavior except for a large increase of dendrite current at  $15.6 \mu\text{g}/\text{cm}^2$  conditions. This indicates the formation of thick dendrites, unlike in other cases. It shows that increased contamination increases the dissolution rate of the metal, which consequently forms thicker and more branched dendrites containing more metal and hydroxide precipitation. The high amount of metal content in the dendrites increases the current leaking through. However, as the potential increases, the probability of migration decreases, which also correlates with a decrease in the dendrite current. This is due to the fact that the rate of dissolution of tin increases with an increase in potential bias similar to increase in contamination. This leads to precipitation of the hydroxide species, while the heavy gas evolution at the anode and cathode also inhibit the formation of dendrites. Minzari et al. [11] have reported similar phenomenon with increase in potential bias or contamination level.

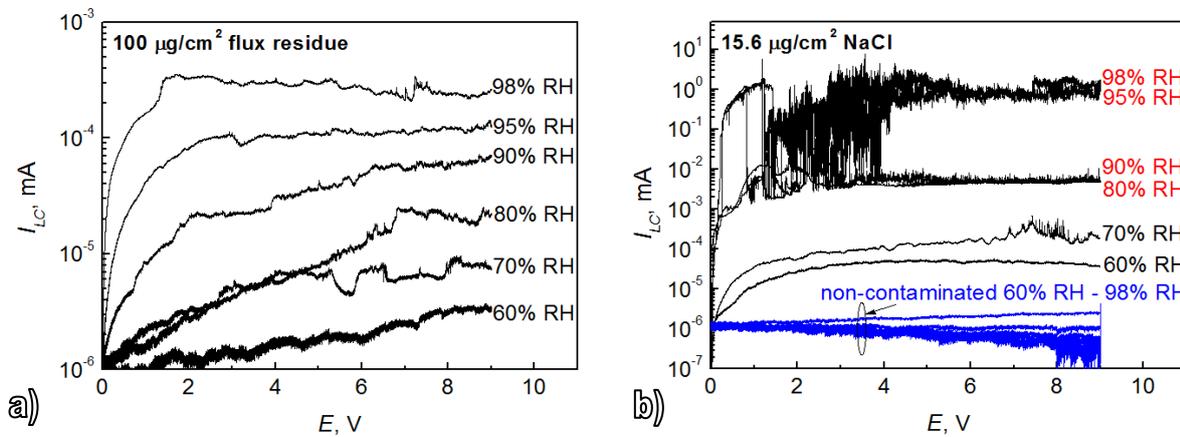
measured in the range from 0 V to 9 V with a sweep rate of 2 mV/s. The measured voltammetry curves as a function of RH are presented in **Figure 8**. The temperature during the experiment was kept constant at 25°C.

**Figure 8:** Leakage current as a function of applied potential and relative humidity: (a) – solder flux residue and (b) – NaCl and non-contaminated surface

The presence of flux residues (Cobar 390-RX-HT) is less effective in generating leakage current at all humidity levels compared to NaCl. With the increase of relative humidity from 60% to 98%, the leak current measured on the SIR comb pattern pre-contaminated with the flux residues has increased somewhat more than two orders of magnitude and no ECM initiation has been observed after the testing. Whereas in case on NaCl a more than four orders of magnitude increase in leak current has been observed when the relative humidity exceeded 80 % value. The observation of considerable increase of leak current is assumed to be an indication of NaCl dissolution and water layer formation on the SIR pattern. According to Kohler theory and Pöschl study on sodium chloride interaction with water vapour, the hygroscopic properties of NaCl enables adsorption of water molecules at RH around 75% [22]. The optical inspection of SIR comb pattern after the experiment revealed dendrite growth between the adjacent conductive lines. The increase of leakage current with increase of RH from 60% to 98%, measured on the non-contaminated SIR pattern was in scale of nA and negligible, indicating an importance of PCBA cleanliness for climatic reliability of electronics.

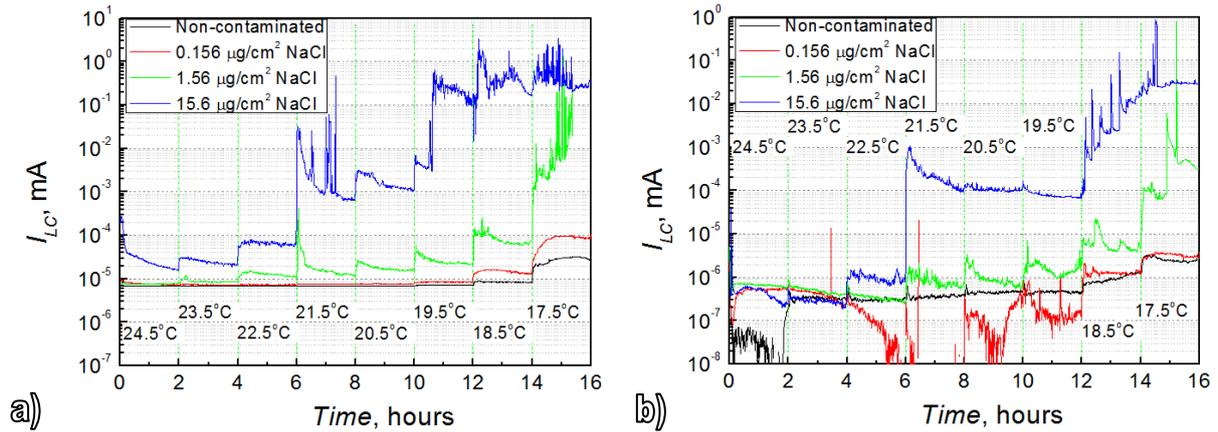
The effect of temperature difference between the PCB surface and surrounding air on the water condensation and leak current was studied on 10 surface mount ceramic chip capacitors connected in parallel and the SIR comb pattern biased at 5 V DC. The temperature of surrounding air has been kept constant at 25 °C. The leak current curves presented in **Figure 9** indicate the increase of current with increased difference in temperature of surrounding air and the surface of the PCB. The temperatures listed on the graphs are the average values of temperatures obtained with two RTD sensors places on the surface of the test PCB.

**Figure 9:** Leakage current measured on test PCB biased at 5 V DC (a) – SIR comb pattern and (b) – 10 ceramic chip capacitors size 0805 connected in parallel

For the non-contaminated condition, the increase of current is very little and it occurs during the last two steps, when the temperature difference between the surrounding air and PCB is sufficient enough for water condensation to occur. The increase of leakage current at  $0.156 \mu\text{g}/\text{cm}^2$  of NaCl occurs at the same steps as it was on a non-contaminated surface, but with slightly higher magnitude of current.

Ionic contamination reduces the critical RH value and increases the leakage currents, as was shown by these experiments. A considerable increase of leak current is detected at concentrations starting from  $1.56 \mu\text{g}/\text{cm}^2$ . A substantial increase of leakage current is observed at complete condensation conditions (very last steps). However at concentrations above  $1.56 \mu\text{g}/\text{cm}^2$ , the critical RH for condensation is reduced to around 75% for both SIR and capacitors.

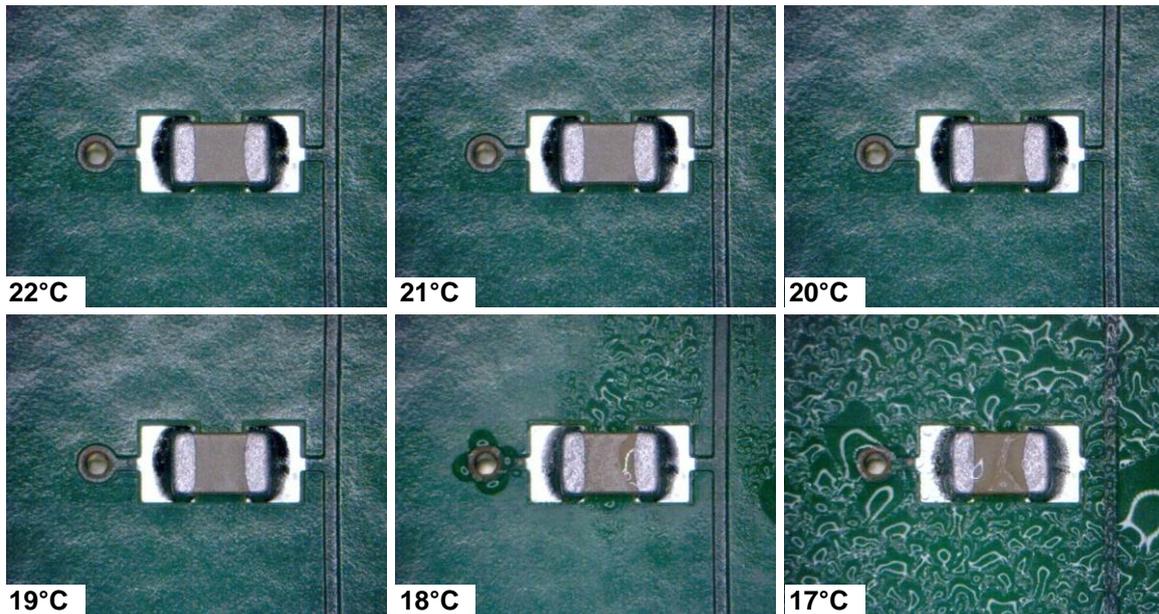
The effect of temperature difference on the condensation is presented in **Figure 10**. The expected error of temperature reading is 1°C. According to the leakage current measurements, the formation of thin water layer starts at 21.5°C, though it is not apparent from the captured images. A further decrease of temperature of the PCB increases the water build up on the surface, which is reflected in the leakage current versus time graphs. The condensation becomes clearly apparent when the temperature on the surface of PCB reaches 18°C.

**Figure 10:** Water condensation on size 0805 chip capacitors pre-contaminated with 15.6 µg/cm<sup>2</sup> of NaCl
