Frost damage of concrete subject to confinement

Hasholt, Marianne Tange

Proceedings of the International RILEM Conference Materials, Systems and Structures in Civil Engineering 2016

FROST DAMAGE OF CONCRETE SUBJECT TO CONFINEMENT

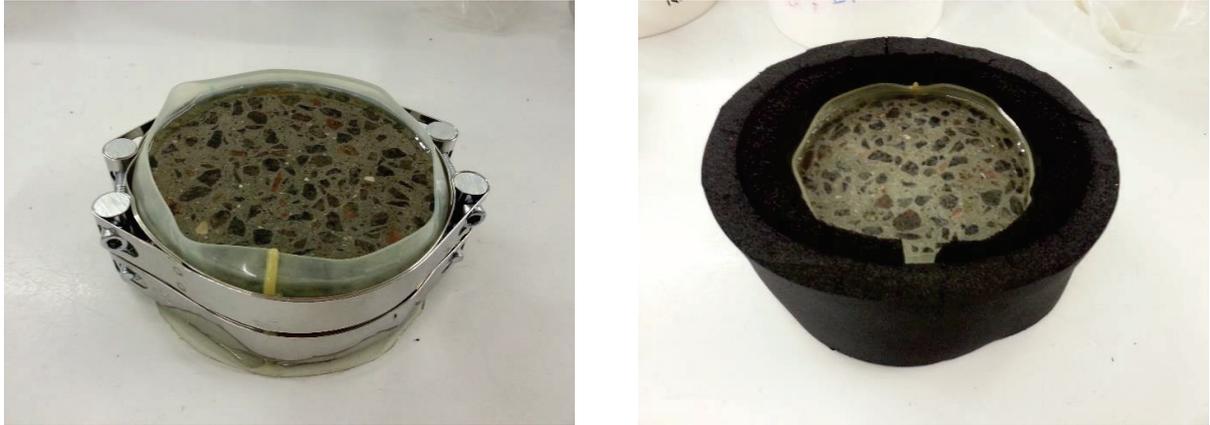
Figure 1: Specimen with hose clamps before (left) and after (right) all surfaces except the test surface had been covered with thermal insulation.

- REF: The specimen was externally unrestrained during freeze/thaw testing, as is the normal test condition. This specimen served as reference of the experiment.
- CLAMP: 2 hose clamps were placed around a concrete disc, each clamp being 25 mm wide. In this way the concrete was subjected to moderate external compression, and concrete expansion became restricted in the radial direction, see figure 1 (left).

The clamps were mounted 28 days after casting, just before the test surfaces were covered with 3 mm de-ionised water. The clamps were tightened by hand with a hex key wrench. The compression enforced by the hose clamps on the concrete specimens was not measured. It was anticipated that the resulting compressive stress in the concrete was small relative to the concrete compressive strength.

31 days after casting, all surfaces except the test surface were covered with thermal insulation, and the de-ionised water was replaced with 3% NaCl solution, before the specimens were placed in a freezing cabinet. The clamps were also covered with insulating material to prevent the metal clamps from forming thermal bridges that would spoil the one-dimensional heat transport through the specimen, see figure 1 (right). In the freezing cabinet, the specimens were exposed to repeated freezing and thawing with temperature cycles complying with [1]. Scaling was collected at intervals as specified in the test standard.

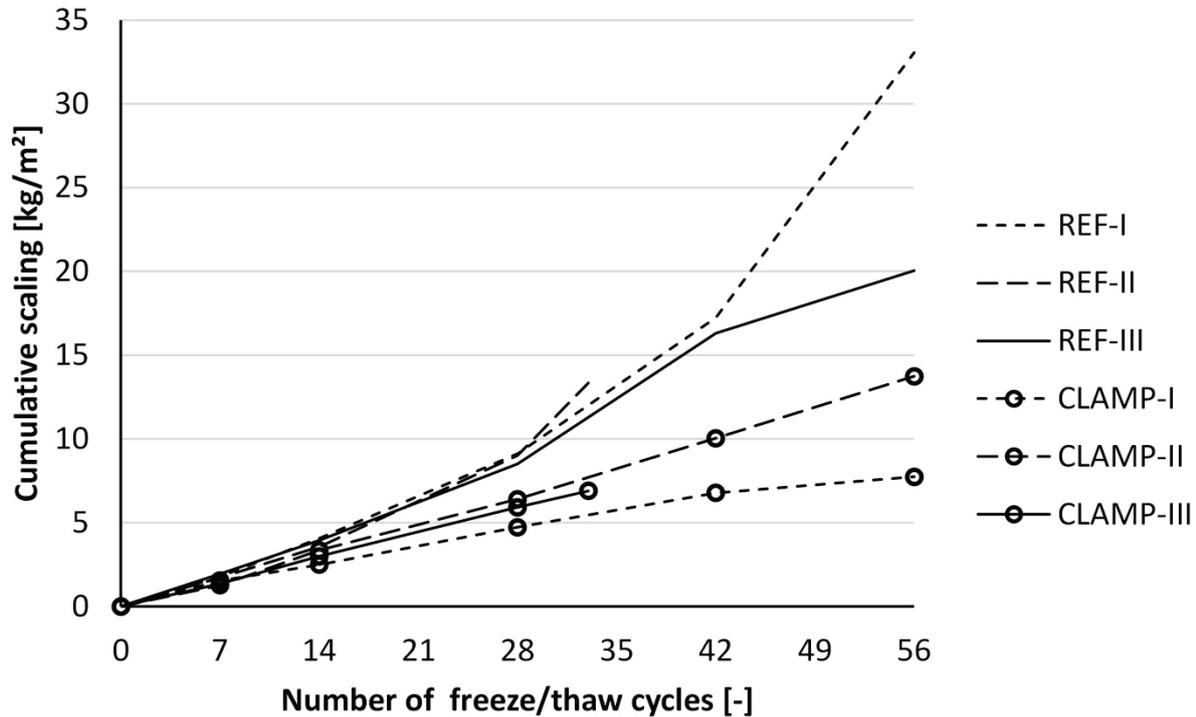
Figure 2: Development in accumulated amount of scaled material. Specimens REF-II and CLAMP-III were removed from the freezing chamber after 33 freeze/thaw cycles.

Results from the freeze/thaw scaling tests are shown in figure 2.

After 28 cycles, the results become more uncertain. After removal of specimens for epoxy impregnation, the areas of test surface for each series REF and CLAMP no longer fulfil the Danish requirement for minimum test surface for the test (minimum 42,000 mm²). Moreover, problems with leakage were discovered for CLAMP-I (detected when collecting scaling after 28 cycles), and REF-III (detected after 42 cycles). This may explain why the accumulated scaling for CLAMP-I is the lowest of the CLAMP series, and REF III shows the lowest scaling of the REF series; if the concrete surface is not covered with NaCl solution in every freeze/thaw cycle, it reduces the amount of scaling.

During the freeze/thaw test, surface scaling was regularly collected, though surface scaling was not the primary focus of the study, as hypotheses A and B do not relate to scaling. The collection of surface scaling was mainly seen as a quality control to identify if one specimen behaved very different from the others e.g. due to casting errors. The results presented in figure 2 show a significant difference in scaling for specimens with and without hose clamps. In the first part of the test period (collection after 7 and 14 freeze/thaw cycles), the amount of scaling of the CLAMP specimens is 20-25% less than the scaling of the REF specimens. It is likely that the confinement imposed by the hose clamps is reduced over time, because the clamps were not tightened during the freeze/thaw test period. If the confinement is relieved over time, the effect of the hose clamps should also level off, but this does not seem to be the case. Actually, the scaling of the REF specimens seems to accelerate, whereas for the CLAMP specimens, the amount of scaling per unit of time is almost constant, and after completion of the 56 freeze/thaw cycles, the cumulated amount of scaling for the CLAMP specimens are less than 50% of the cumulated amount for the REF specimens.

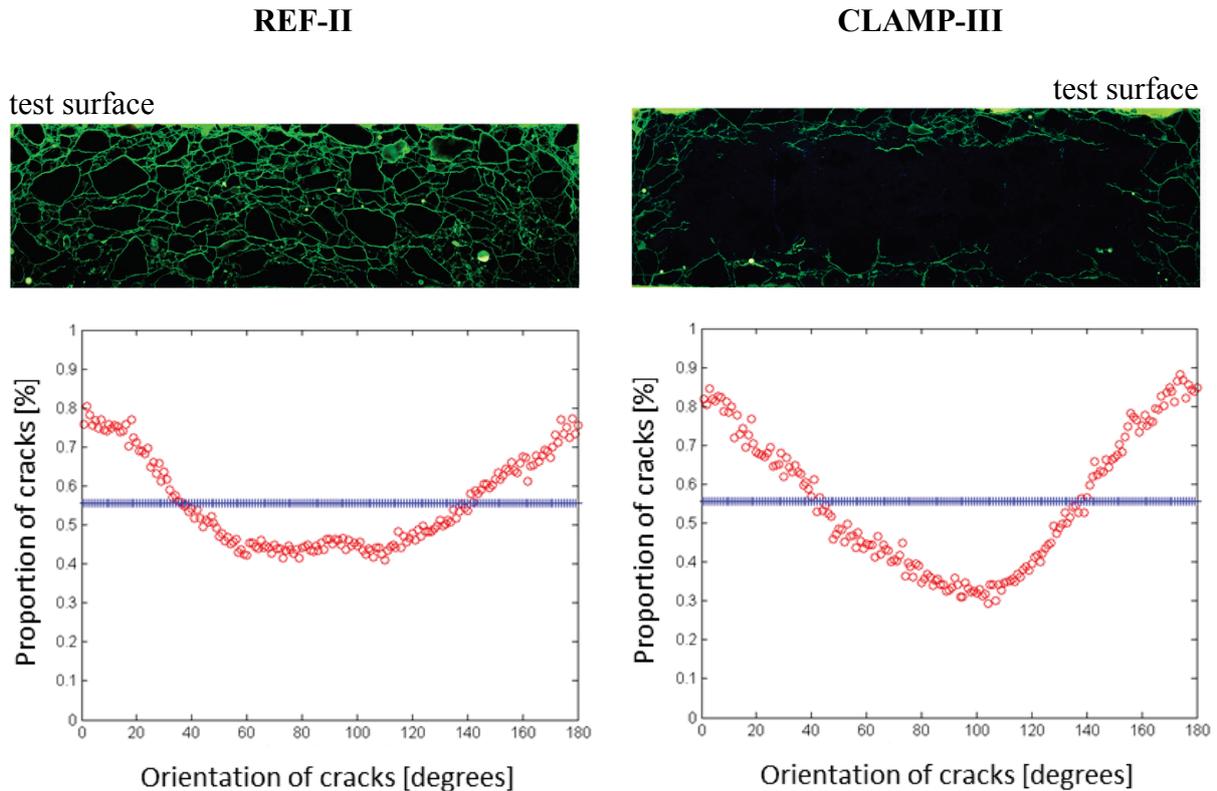
Figure 3: Top: Epoxy impregnated plane sections under UV light (width of each plane section is 150 mm). Bottom: Diagrams showing distribution of crack orientations. Crack orientation $0^\circ / 180^\circ$ corresponds to cracks parallel to the test surface. Horizontal lines at $1/180 = 0.56\%$ correspond to random crack orientation.

Figure 3 shows the epoxy impregnated plane sections for the specimens REF-II and CLAMP-III. The pictures are scaled to the same size. The reason why the height of CLAMP-III is slightly larger than the height of REF-II is because several millimetres of the test surface of REF-II had scaled off.

Figure 3 also shows analyses of crack orientation made with the method described in [5]. REF-II is cracked throughout the specimen, but for CLAMP-III, a large area at the centre of the specimen is uncracked. To make the analyses comparable, they are for both specimens based on the upper 300 pixel rows (approximately 12 mm), corresponding to the cracked area of CLAMP-III beneath the test surface. The orientation 0° / 180° corresponds to cracks parallel to the test surface.

Though the REF-II specimen had not fallen to pieces during the 33 freeze/thaw cycles, the epoxy impregnated plane section showed that it was completely cracked from top to bottom. Based on a purely visual inspection, the crack orientation was judged to be “random”. However, the image analysis (figure 3, left) shows that there tend to be more cracks parallel to the test surface than perpendicular to the surface. Some of the cracks follow the interfacial transition zones of the coarse aggregates, so one possible explanation is that this outcome is due to the casting direction. The coarse aggregate was crushed granite, where some of the particles are flaked; if they systematically take bearing in a certain direction, e.g. when the moulds are vibrated during casting, this may induce a systematic trend in crack orientation. Another possible explanation may be the geometry of the test specimens. The REF specimens are not subject to an outer constraint on specimen movement. But the geometry where the specimen is wider than it is tall may restrict movements more in one direction than in others.

When comparing the observed distribution of crack orientations for REF and CLAMP, there are more surface parallel cracks and less cracks perpendicular to the surface for the CLAMP

However, the most striking difference between the two specimens is not the difference in crack orientation but the extent of damage. The CLAMP specimen is not as heavily damaged as the REF specimen. The CLAMP specimen is cracked up to 10-15 mm from all free surfaces of the specimen, but further away from the surfaces, no cracks are seen. This is probably related to the availability of free water for ice formation inside the concrete. Cracks perpendicular to the test surface contribute to water transport into the concrete, whereas cracks parallel to the surface do not. Moreover, it may also play a part that for the REF specimen, there are more favourable conditions for widening the cracks during frost action, so they can transport more water, because the movement of the specimen is unrestricted. According to [6], mechanical stress has only a small effect on concrete permeability, as long as the stress level is less than 40% of the concrete strength. At higher stress levels, the mechanical action may lead to cracking, thereby increasing the permeability several orders of magnitude. The crack width also has a pronounced effect.
