## Electro-desalination of glazed tile panels - discussion of possibilities

International RILEM Conference on Materials, Systems and Structures in Civil Engineering

## **ELECTRO-DESALINATION OF GLAZED TILE PANELS – DISCUSSION OF POSSIBILITIES**

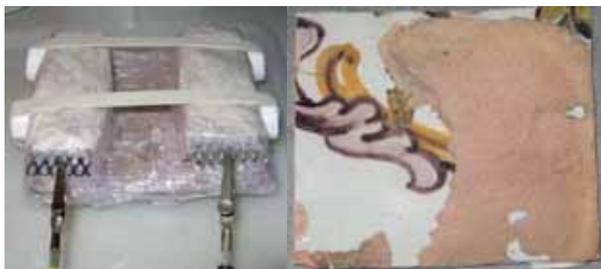
Figure 3: (a) Experimental setup for desalination of single tile; (b) 20<sup>th</sup> century tile used in lab experiment.

Experiments have been reported with electro-desalination of single tiles in the laboratory [10-12]. The experimental setup of these is illustrated in figure 3a. The tiles were placed with the glaze down and because they had dried out during indoor storage, water was sprayed on the back side before placing the electrode compartments (poultice and inert electrode mesh) as far apart as possible. The tile and electrode compartments were wrapped in plastic to hinder evaporation of water, which would hamper the passage of electric current. A constant current was then applied to the electrodes. Moist pores are needed in order to be able to have passage of current through the biscuit. In cases, where salt decay is problematic, water must be present at least during some periods and it is assumed that it is not neither necessary to add extra water or cover the wall as in the laboratory atmosphere with very low RH.

An experiment with electro-desalination of a Portuguese 20<sup>th</sup>-century tile (figure 3b) has also been conducted (not previously published). The average initial concentrations were 700 mg  $\text{Cl}^-$ /kg and 930 mg  $\text{SO}_4^{2-}$ /kg and thus the salt contamination was much less than the older tiles from Palácio Centeno. After 3 weeks with 1 mA applied 76%  $\text{Cl}^-$  and 87%  $\text{SO}_4^{2-}$  were removed. Hereby it was shown that also this biscuit type can be desalinated.

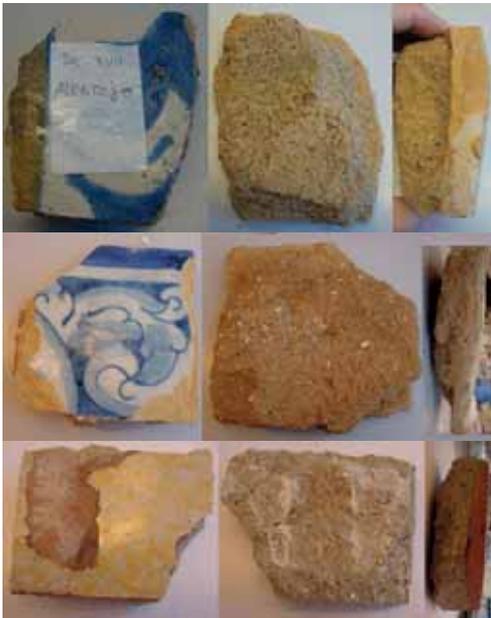
Figure 4: experimental tiles with mortar. Top: 17<sup>th</sup> century tile from Alentejo (PT); middle: 18<sup>th</sup> century tile from Palacio Centeno, Lisbon; bottom: 20<sup>th</sup> century tile of unknown origin.

Brammer & Sveegaard [15] and Ferreira et al [16] reported laboratory results with electro-desalination of three tiles from different centuries. Mortar was attached to the tiles in these investigations (see figure 4). Each of the three tiles was broken. The tiles were: 17<sup>th</sup>-century tile from the Alentejo Region (mortar very hard and unfortunately not considered original), 18<sup>th</sup>-century tile from Palácio Centeno, Lisbon (mortar very porous and loose, considered original) and 20<sup>th</sup>-century tile of unknown origin (mortar was hard, but is considered original). Initial samples were taken from both tile and mortar prior to the desalination experiments. From the first two tiles it was only one sample from both. The 20<sup>th</sup>-century tile was separated into two pieces where one was used to find the initial salt concentration and the other for the desalination experiment.
