The impact of tool wear on the functionality of replicated polymer surface with micro structures

Publication date:
2017

Li, D., Zhang, Y., Regi, F., Tosello, G., & Nielsen, J. B. (2017). The impact of tool wear on the functionality of replicated polymer surface with micro structures. Abstract from Polymer Replication on Nanoscale: 4th International Conference, Aachen, Germany.

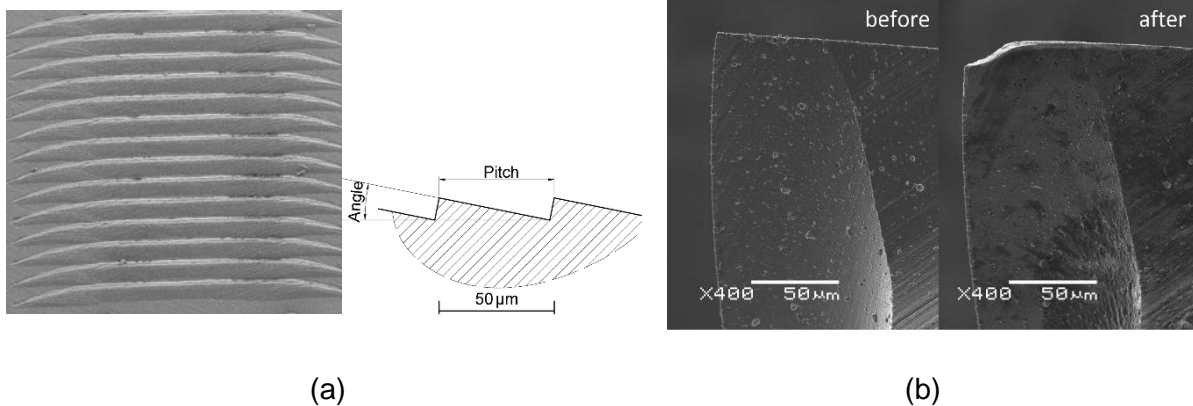
Figure 1: (a). Structures on the surface; (b). Wear on the tip of the tool was observed after machining

In order to conduct the study, 1200 pixels (0.8 x 0.8 mm²) was machined on the surface of a steel insert using the same mill tool (Φ 0.5 mm, ARNO®); each of the pixels contains 16 ridges which is illustrated in figure 1 (a). The obtained surface structures were replicated using liquid silicon rubber (LSR).

Results in this study include: 1. Tool wear was visualized by SEM images, which is shown in figure 1 (b). 2. However, the weight decrease could not be detected due to lack of precision in the measurement. 3. The number of defects on the obtained surface structures increased significantly along with the process. 4. The reflectance of these pixels on the LSR replica decreased from the first machined one to the last one.
