High temperature corrosion under conditions simulating biomass firing: depth-resolved phase identification

Okoro, Sunday Chukwudi; Montgomery, Melanie; Jappe Frandsen, Flemming; Pantleon, Karen

Published in:
Proceedings of EUROCORR 2014

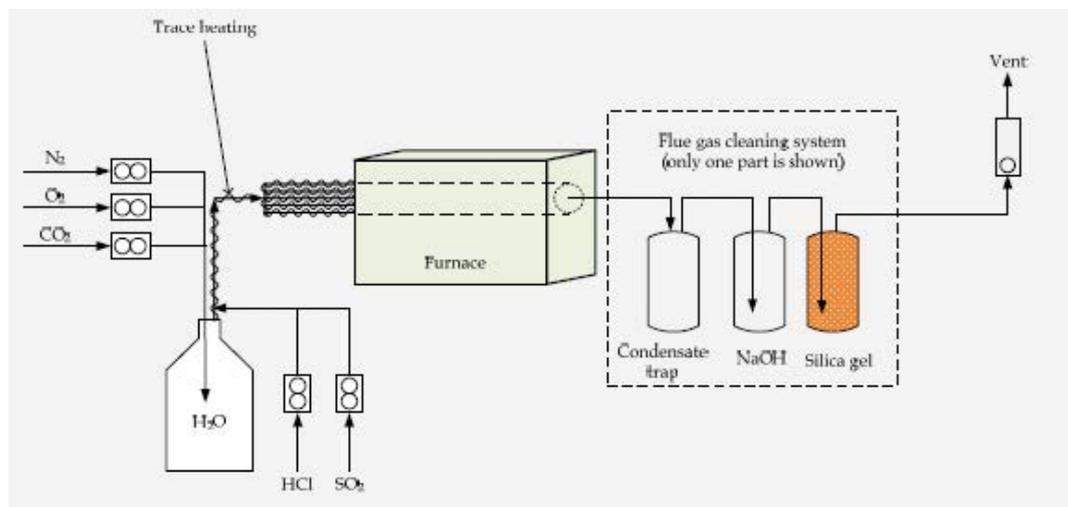
Figure 1: A schematic illustration of the corrosion test rig used for simulating high temperature corrosion during biomass firing.

An austenitic steel tube of the steel TP 347H FG was investigated in this study. The alloy was determined by EDS to contain 18.1wt% Cr, 10.3wt% Ni, 2.0wt% Mn, 0.4wt% Si, 0.5wt% Nb and 68.7wt% Fe. The tube was cut into sections, degreased in acetone and ethanol before coating with a synthetic deposit slurry. The deposit slurry was made by mixing KCl with isopropanol. The coated specimens were exposed to conditions simulating straw firing in a corrosion test rig at 560 °C for 168 h. The rig consists of a gas mixing panel, an electrically heated horizontal furnace, and a gas cleaning system. 6% O₂, 12% CO₂, 400pmv HCl and 40ppmv SO₂ were fed from gas cylinders into the reactor using mass flow controllers. The gas composition was chosen to simulate the worst case flue gas composition in a straw fired power plant with respect to HCl. H₂O vapor was incorporated into the flue gas by passing the mixture of CO₂ and O₂ through a water bath before feeding it into the reactor. Nitrogen was used as a carrier gas. Fig 1 shows a schematic of the corrosion test rig.

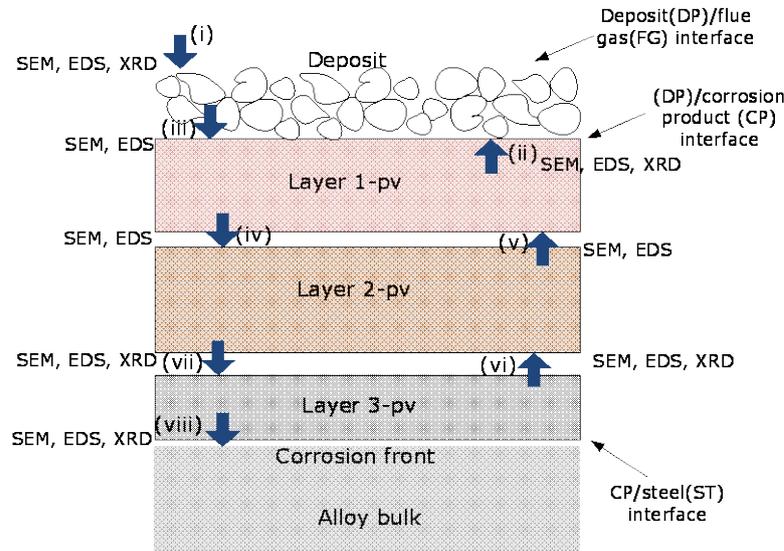
removal. Fig 2 shows a schematic of the plan view, ‘top-down’ characterization process. The blue arrows in the schematic show the directions from which investigations were carried out. The applied characterization techniques are also shown in relation to the investigated locations within the sample.

Figure 2: A schematic illustration of the plan view, ‘top-down’ characterization process employed for depth-resolved characterization of the corrosion product.

The plan view, 'top-down' characterization of the corrosion product started with investigation of the initial deposit of a non-embedded sample. This was followed by step-wise removal of the corrosion products using a scalpel or SiC paper, followed by subsequent characterization of the various surfaces revealed by successive layer

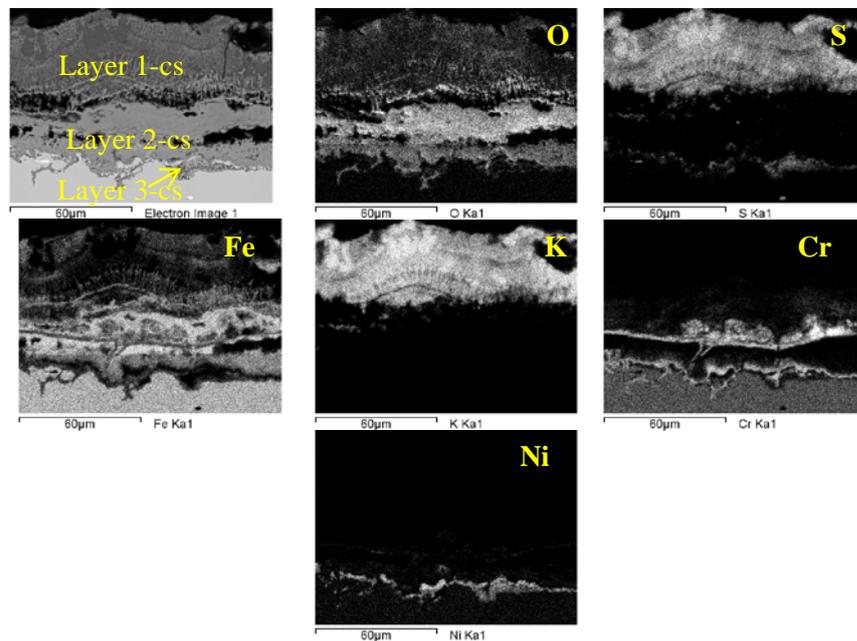
Figure 3: SEM image and corresponding EDS maps showing the distribution of the various elements across a cross section of the corrosion product.

A cross section of the corrosion product below the deposits is shown in Fig 3. Three layers of the corrosion product can be identified from the SEM image and the corresponding EDS maps show the composition of the different layers. The first layer (layer 1-cross section (cs)) consists of K, S, O and some Fe. The second layer (layer 2-cs) contains Fe, Cr and O. The third layer (layer 3-cs) consists of mainly Ni and S. The chemical element distributions, in the different layers suggest that the corrosion of the alloy proceeds according to the active oxidation mechanism, sustained by Cl [5], [8]. The sulphation of the deposit (KCl) by SO₂ (equation 1), is responsible for the formation of K₂SO₄ as observed in layer 1-cs. However such reaction also generates HCl/Cl (depending on the presence on H₂O).

The elemental composition of the second layer (Figs. 5b and c) is similar to that observed from EDS maps in Fig 3. This layer consists predominantly of the oxides of the alloying elements of the investigated alloy. In Fig 6, the XRD results of qualitative phase analysis carried out at different locations on the corrosion product starting from the initial deposit surface are shown. The complementary use of results from EDS analysis supported identification of the crystalline phases present as a function of depth in the corrosion product. It is seen that both KCl and K_2SO_4 are present in the initial deposit after exposure to straw firing conditions. On the layer 2-pv of the corrosion product, Fe_2O_3 and $FeCr_2O_4$ are identified. This is in agreement with the elements identified by EDS analysis in Figs 5 (b-c).

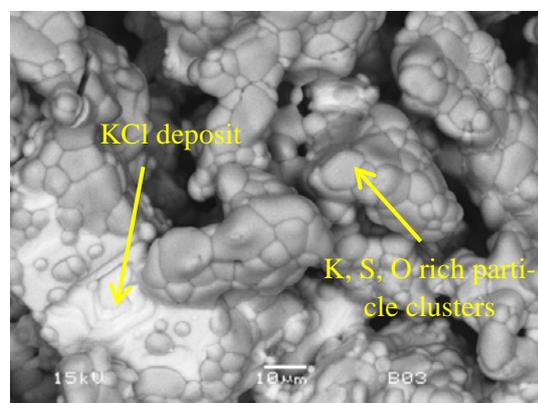
Figure 4: The initial deposit after exposure to simulated straw firing conditions.

Plan view, ‘top-down’ characterization of the corrosion product allowed a comprehensive and complementary use of different techniques which resulted in an improved investigation of the morphology and chemical composition. In Fig 4, the morphology of the initial deposit is shown. It is seen that some particle clusters of changed chemical composition have accumulated around the initial KCl deposit. By EDS analysis, K, S and O have been identified on these particle clusters.

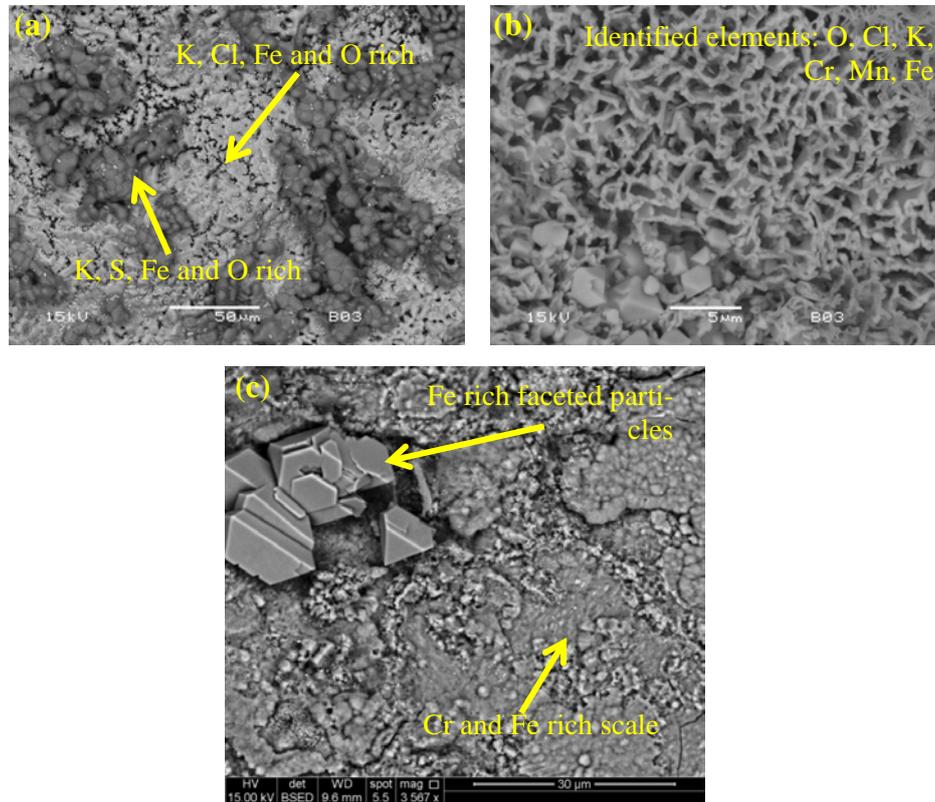
Figure 5: Corrosion product morphology as observed by plan-view 'top-down' investigations. (a): The first layer of corrosion product (layer 1-pv). (b and c): the second layer of corrosion product (layer 2-pv).

The first layer of corrosion product (layer 1-plan view (pv)) as observed from plan view investigation is shown in Fig 5a. This is observed to consist of regions rich in K, Cl, Fe and O, and other regions rich in K, S, Fe and O

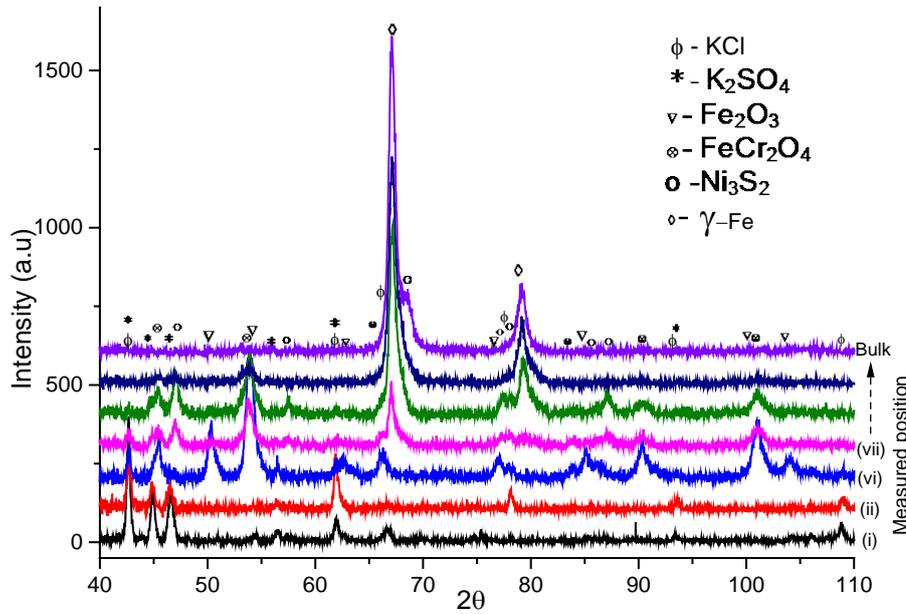
Figure 6: X-ray diffractograms recorded from different positions in the corrosion product after stepwise layer removal. The corresponding positions are shown in Fig 2.

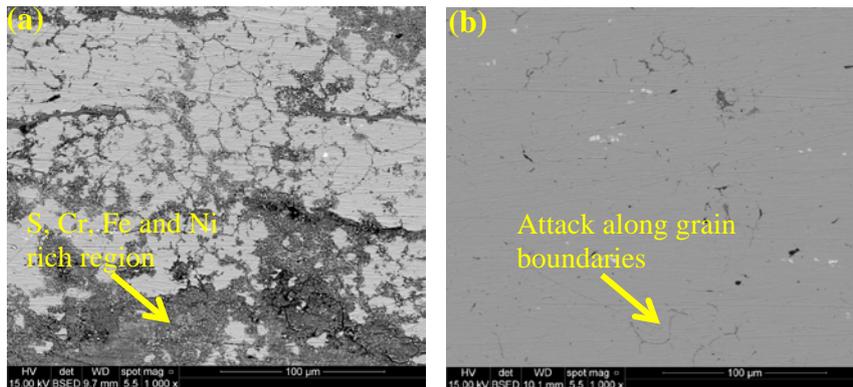
Figure 7: Selective attack on the third layer of corrosion product (a), and attack along grain boundaries at locations below layer 3-pv (b), as observed from plan view investigation.

Figs 7 (a-b) shows the selectively attacked regions presumably due to preferential attack of Cr and Fe where Ni is left behind as a skeleton. As the bulk of the alloy is approached through removal of the corrosion product by grinding, selective attack is observed to occur along grain boundaries. The elemental composition of layer 3-pv showed the presence of Cr, Fe, Ni and S. XRD diffraction measurements showed the presence of Ni_3S_2 , which supports the identification of S and Ni bands in this layer as suggested from the EDS maps in Fig 3.
