Magnesium-oxide boards cause moisture damage inside facades in new Danish buildings

International RILEM Conference on Materials, Systems and Structures in Civil Engineering 2016

MAGNESIUM-OXIDE BOARDS CAUSE MOISTURE DAMAGE INSIDE FACADES IN NEW DANISH BUILDINGS

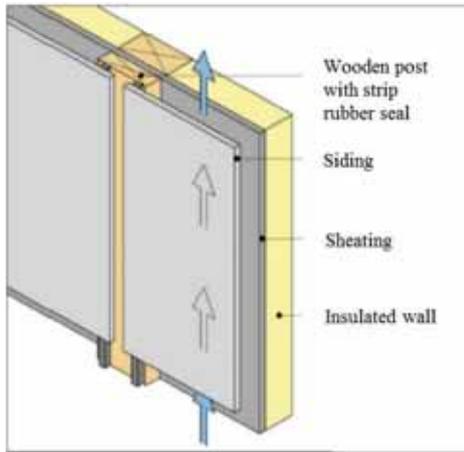
Figure 1: Sketch of a typical façade construction where a sheathing board is used as wind barrier. Adapted from [1].

In winter 2014/15, many moisture damages were observed inside ventilated facades of new or newly renovated Danish buildings. The moisture damaged facades were constructed with sheathing made of magnesium oxide boards (MgO-boards) facing the air gap behind the material used for exterior siding. MgO-boards have often been used as sheathing behind a ventilated air gap as shown in Figure 1 and Figure 3. A photo of a MgO-board is shown in Figure 2.

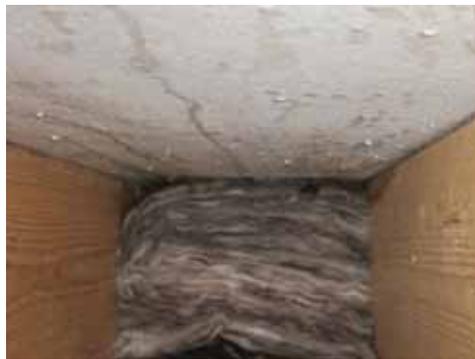
Figure 4: Salty water drops on a vertical MgO-board on the side that faces the insulation filled cavity inside the wall.

The observed damages were caused by the fact that MgO-boards absorb moisture from outside air. Water drops containing chloride ions appear on the outside of the boards – often so many that they run down the vertical boards and out via the air gap behind the siding boards (see Figures 4 and 5). The metal mountings for the MgO-boards can corrode heavily within a few years, cf. Figure 6.

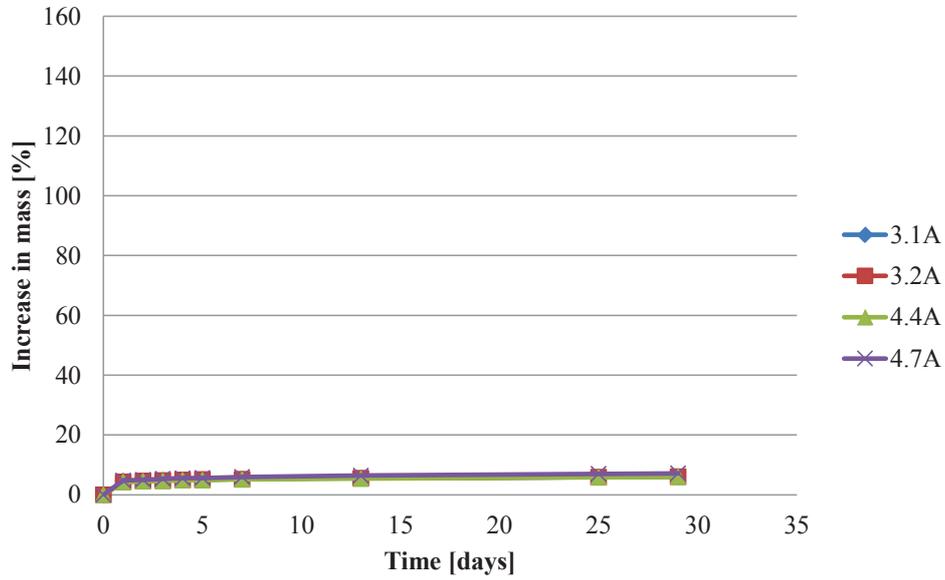
Figure 11: Course of the moisture retention at 35% RH.

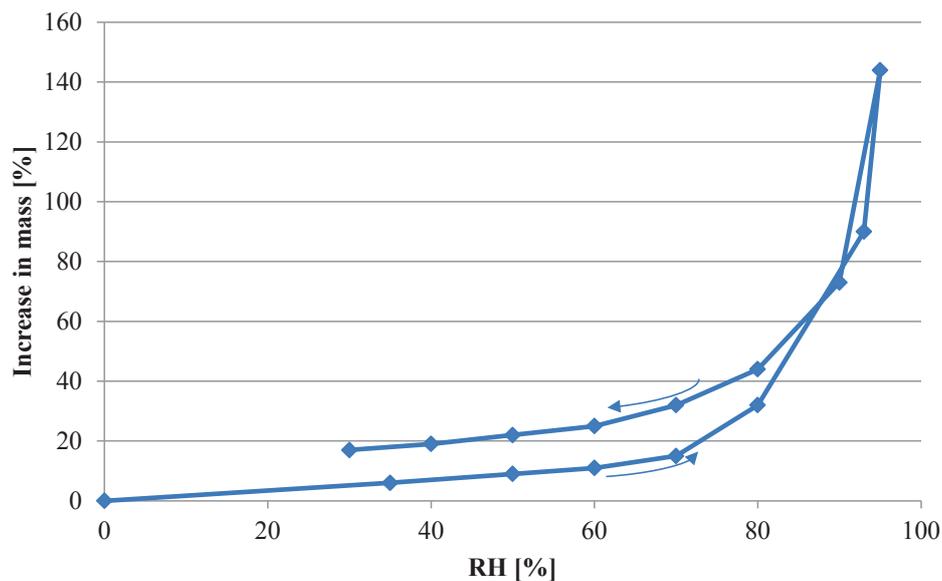
Figure 15: The results of the absorption and desorption measurements for specimen 3.2.

Absorption was measured for specimens that were originally used for initial moisture absorption at 35% RH. The absorption points were measured from 35% RH and up to 92% RH. An example of the results of the absorption and desorption measurements is shown in Figure 15.
