11th Nordic Symposium on Building Physics, NSB2017, 11-14 June 2017, Trondheim, Norway

# Moisture damage with magnesium oxide boards in Danish facade structures

## Abstract

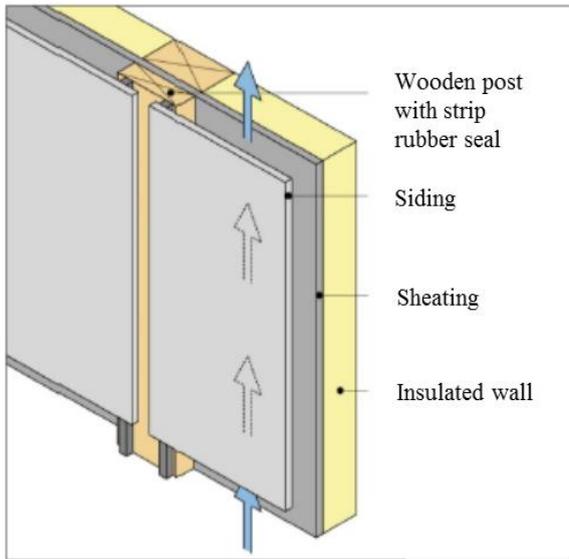
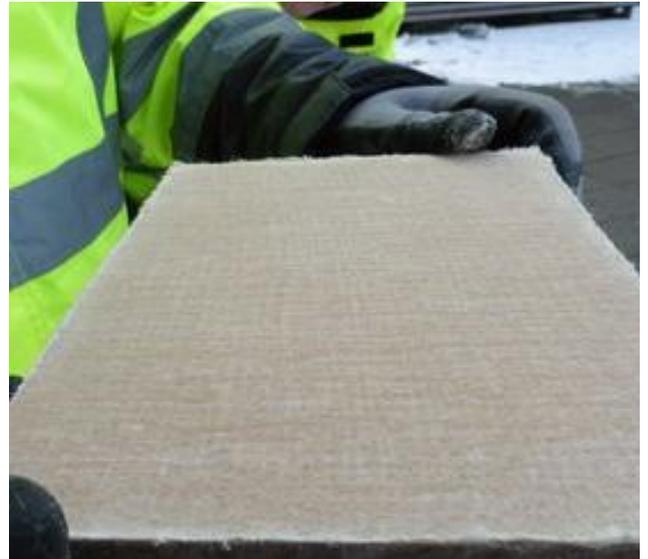
Fig. 1. (a) Sketch of a typical façade construction where a sheathing board is used as wind barrier. Adapted from [1]; (b) Photo of 8 mm thick MgO-board with a glass fibre mesh on both surfaces.

Many moisture damages were observed in winter 2014/15 in ventilated facades of new or newly renovated Danish buildings. The damaged facades had magnesium oxide-boards (MgO-boards) as sheathing facing the ventilated air gap behind the exterior siding. MgO-boards have often been used as sheathing behind a ventilated air gap as shown in Figure 1a and Figure 2a. A photo of an MgO-board is shown in Figure 1b. Examples of saltwater leaks and subsequent damage are shown in Figure 2b, 3a and 3b.

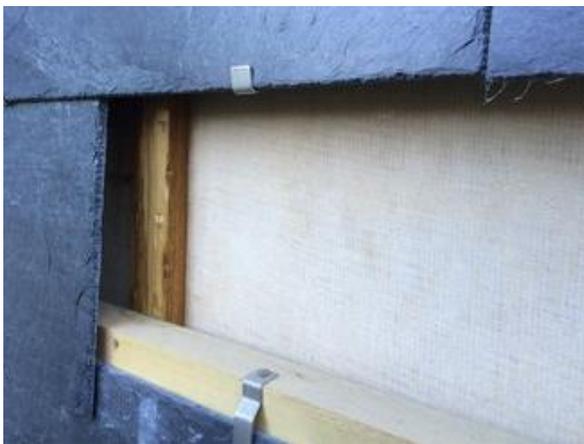
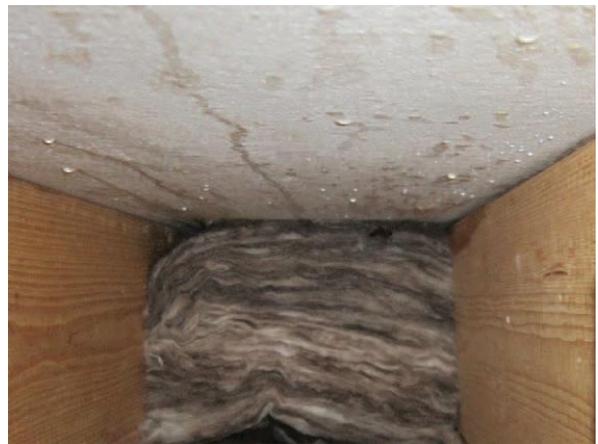
Fig. 2. (a) The MgO-board is placed facing the air gap, which is behind the siding boards made of natural slates; (b) Salty water drops on a vertical MgO-board on the side that faces the insulation filled cavity inside the wall.

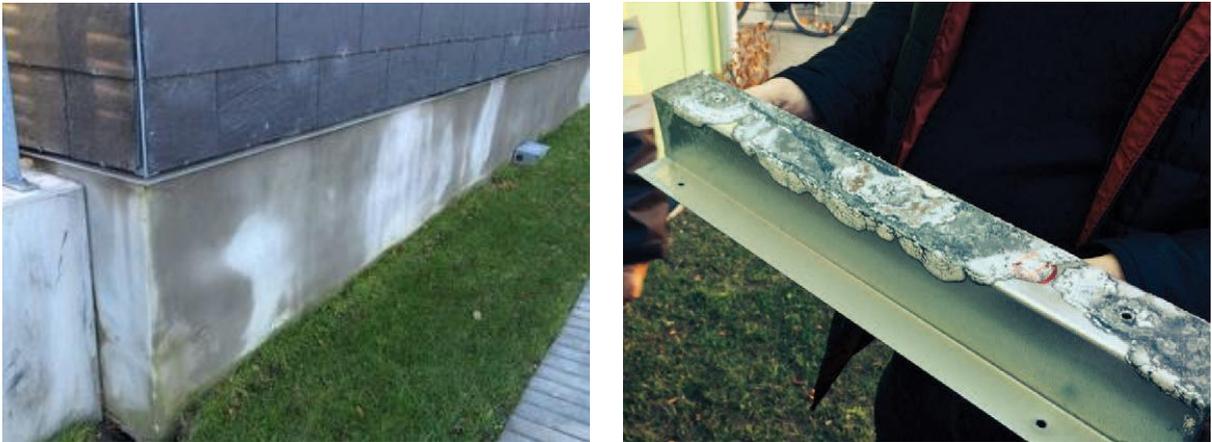
Fig. 3. (a) Water drops containing chloride ions run down the vertical MgO-boards and drain out of the wall from behind the wall's siding boards; (b) Zink covering of the steel profile is corroded as a result of direct contact with salty leaked water from the adjacent MgO-board.

Salt from MgO-boards is highly corrosive on metal fasteners and profiles. Zink flashings of 0.8 mm corrode in 1-2 years. Electro galvanized steel profiles, nails and screws will corrode through to the steel in 1-2 years. Aluminum alloys have different resistance against corrosion and the best alloys have been seen undamaged for 2-3 years. Stainless steel of A2 and A4 can be used without problems. When MgO boards have been sitting on a wooden structure, MgCl<sub>2</sub> salt will have been absorbed by the wood, which is then corrosive to metallic fasteners other than stainless steel.

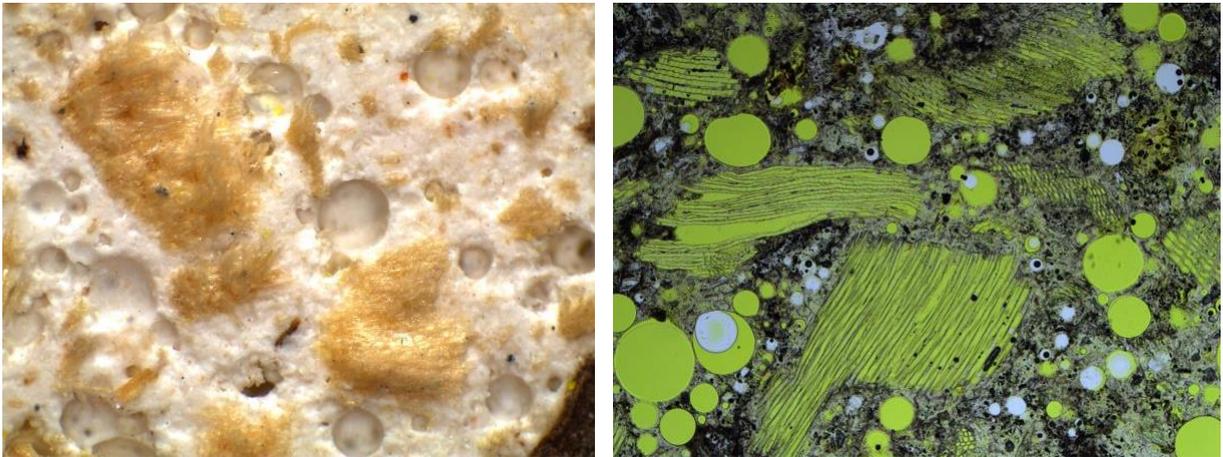
Fig. 4. (a) Cut of a MgO-board investigated in a stereo microscope at 10 times magnification; (b) Micro analysis of a thin section of a specimen at 50 times magnification.

The binder in MgO-boards is formed by a chemical reaction between MgO and  $\text{MgCl}_2$ , typically in a weight ratio of 2.5-3.5 parts MgO to one part  $\text{MgCl}_2$ . The product is quite similar to Sorel cement, which was first produced by Stanislas Sorel in 1867 [2] and used as a flooring material. Various explanations about the product and its possible use and qualities can be found in literature [3-10]. The hydrated product is hard and strong but the product decomposes over time by contact with water or air at high relative humidity (RH). MgO-boards often have organic additions, such as sawdust, and inorganic fillers such as sand, lime or volcanic ash. Figure 4a shows a picture of an MgO-board from a stereo microscope at 10 times magnification. Figure 4b shows a microanalysis of a thin section of a specimen at 50 times magnification that reveals that the investigated MgO-board contains a high amount of very porous organic material, and a high number of fine spherical air pores. All investigated MgO-boards have glass fibre felt as facer.

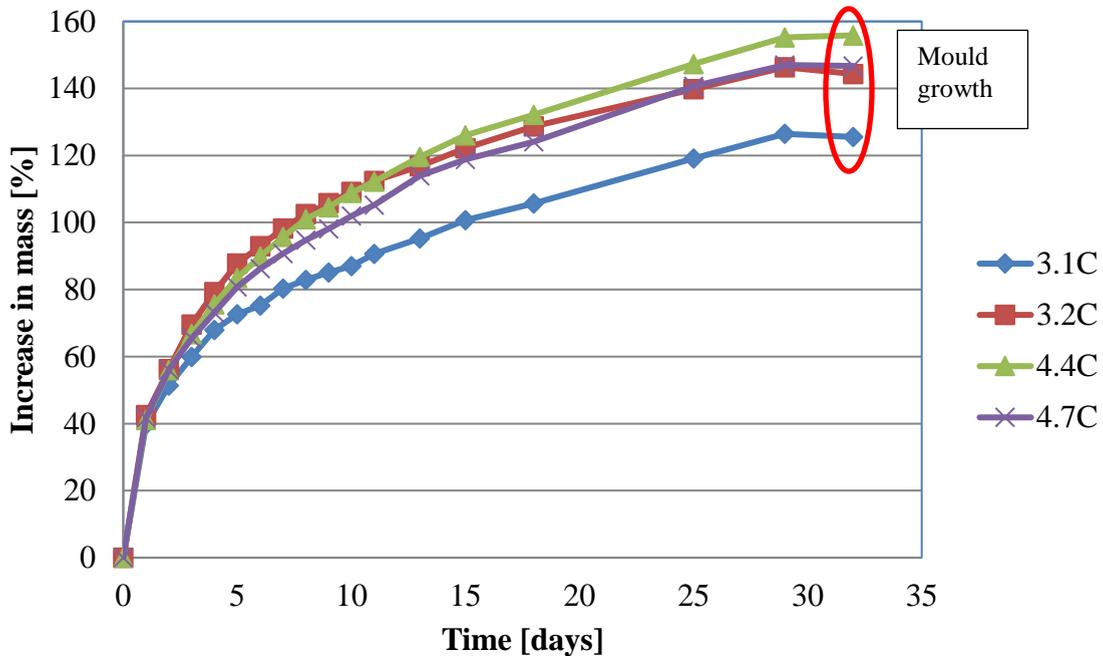
Fig. 5: Course of the moisture retention at 95% RH.

Moisture absorption in MgO-boards from the surrounding air was measured at three different levels of relative humidity at 23 °C: 35% RH, 80% RH and 95% RH. Before start of the moisture exposure, samples of size 5 x 4 x 3 mm were dried at 105 °C for 4 days. MgO-samples with a total weight of about 2 g were put in a petri dish, which was placed in a Teflon basket, and weighed without removal from the climate chambers. The specimens were weighed after 0, 1, 2, 3, 4, 5, 7 days and after 2 and 4 weeks. Specimens exposed to 35 % RH reached 6-7 % moisture content by weight after a week and then remained at that level, while specimens exposed to 80 % RH reached 26 % by weight after a week, and about 30 % after 4 weeks (48 % for one of the specimens). Results are presented in Figure 5 for specimens exposed to 95 % RH. Mould growth was seen after 30 days of exposure to 95% RH.

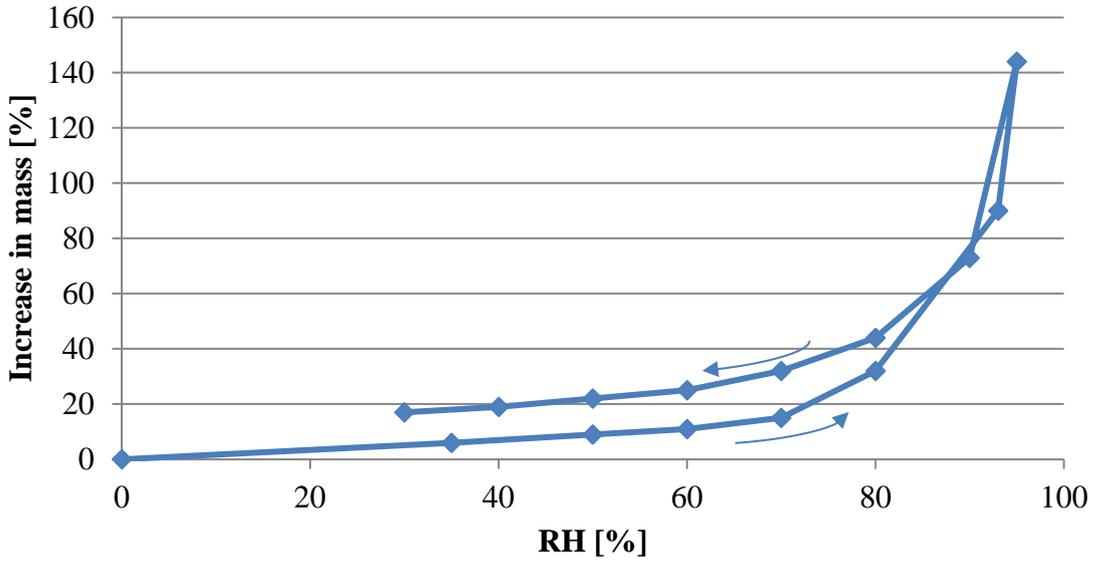
Fig. 6: Results of the absorption and desorption measurements for one of the specimens.

Absorption was measured for specimens that were originally used for initial moisture absorption at 35% RH. The absorption points were measured from 35% RH and up to 92% RH. An example of the results of the absorption and desorption measurements is shown in Figure 6.
